South Bay Community Development District

TO: South Bay CDD Board
FROM: Richard Brylanski, PE
DATE: August 2, 2023
SUBJECT: Clarson Seawall Inspection Report Executive Summary

Mr. Richard E. Brylanski, PE, Little Harbor Marina/South Bay CDD
RE: Seawall Inspection Report – 606 Seagrape Dr, Ruskin, FL 33570
July 12, 2023
Page 23

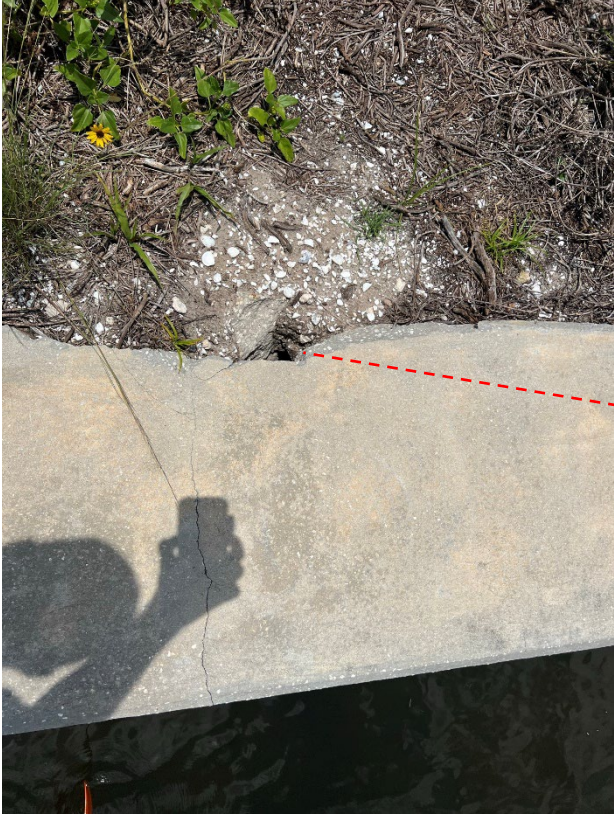
Photo #2 – Spalling in the Cap and Sediment Loss

Spalling/
Chipping

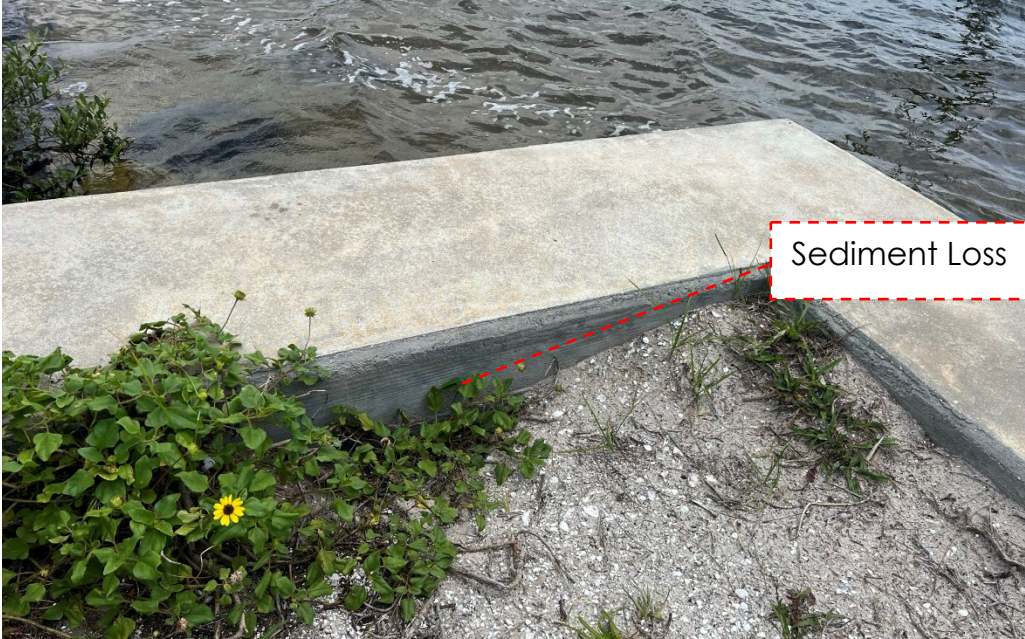
Photo #3 – Sediment Loss.

Sediment Loss

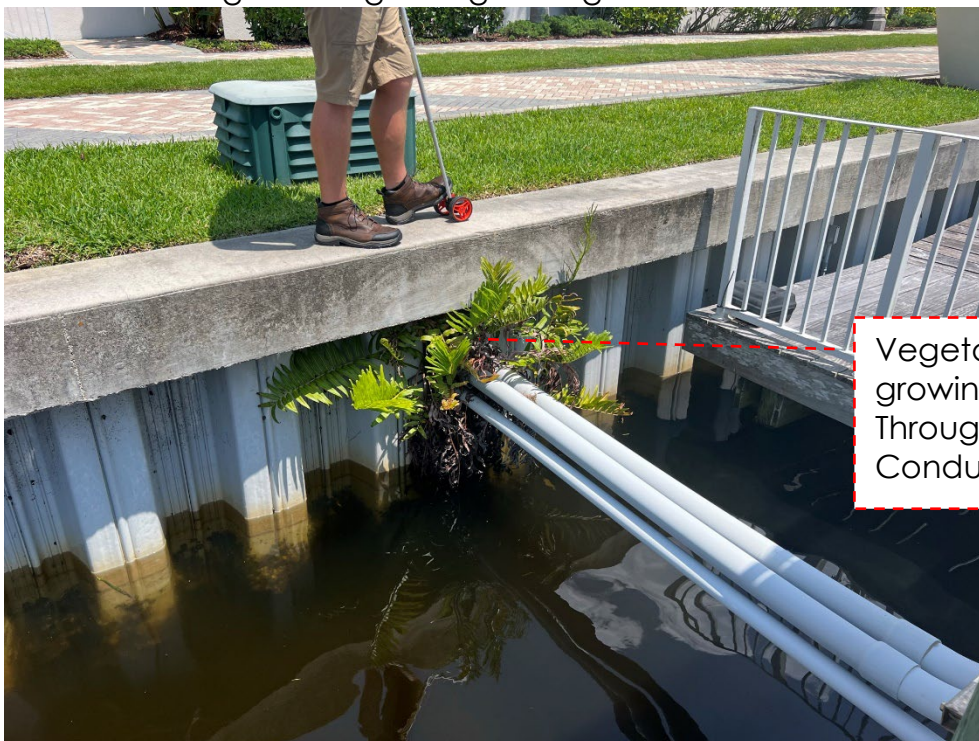
Photo #5 – Vegetation growing Through Conduit.

Vegetation
growing
Through
Conduit

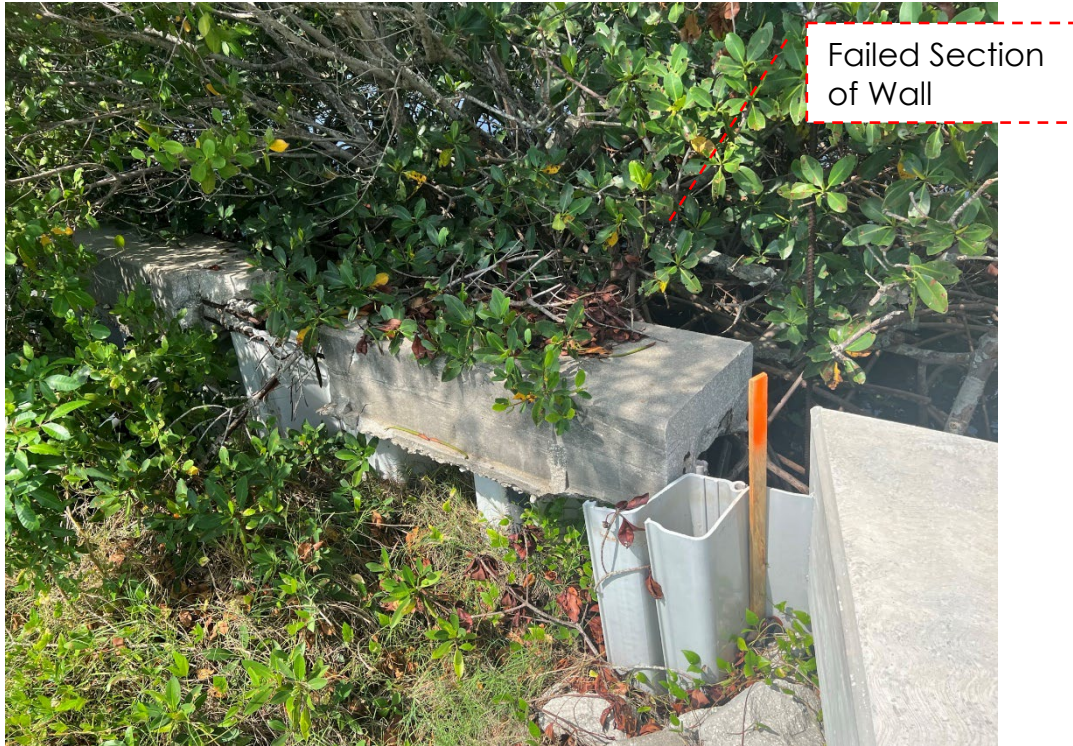
Failed Area in Section 1 (Station 3,878 – 3,986 ft)

Photo #6 – Failed Section of Wall.

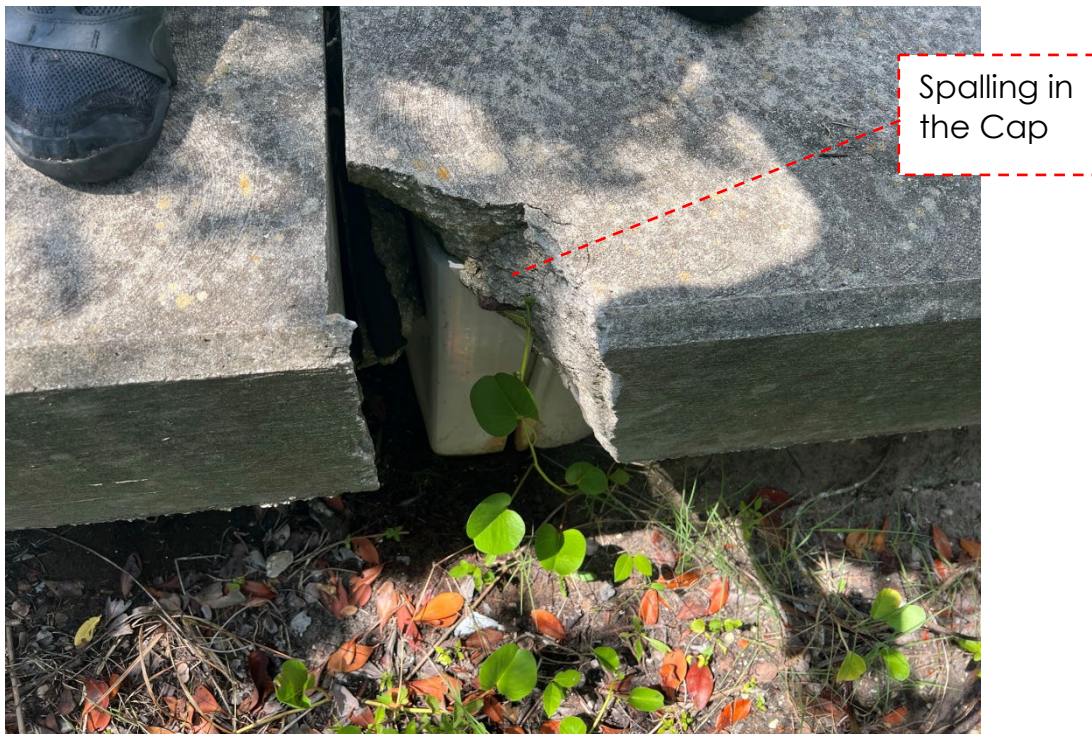
Photo #7 – Typical Spalling of Concrete Cap.

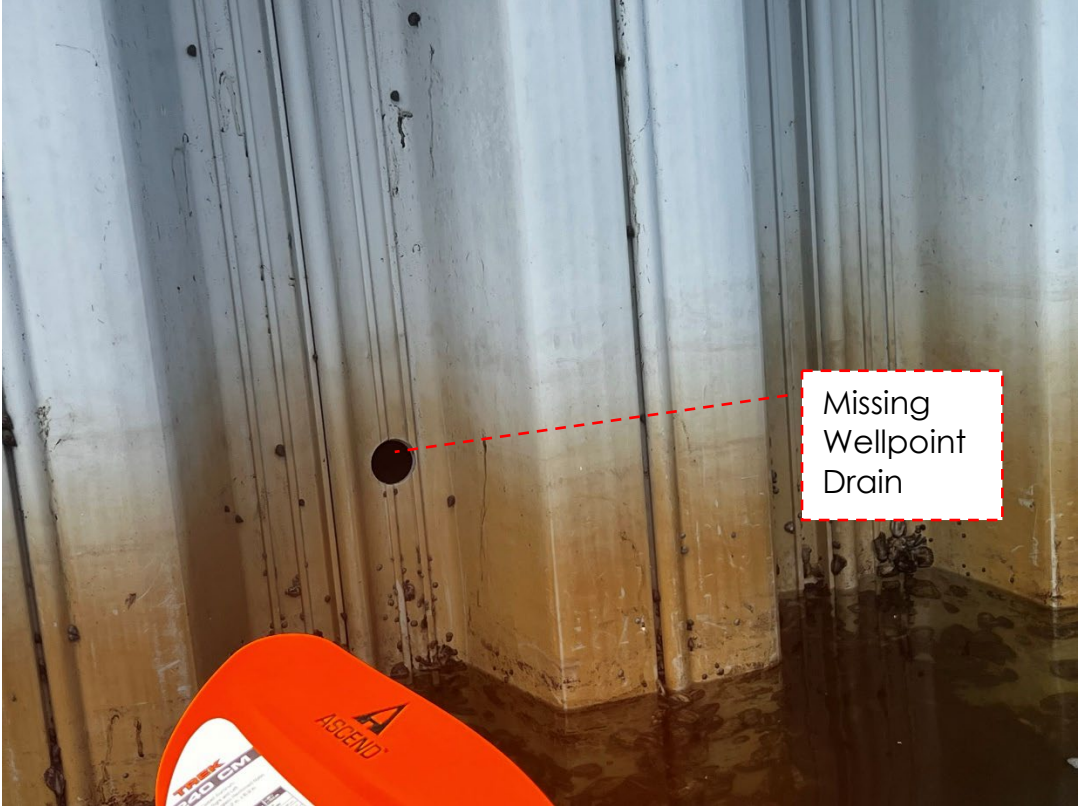
Photo #2 – Missing Drain

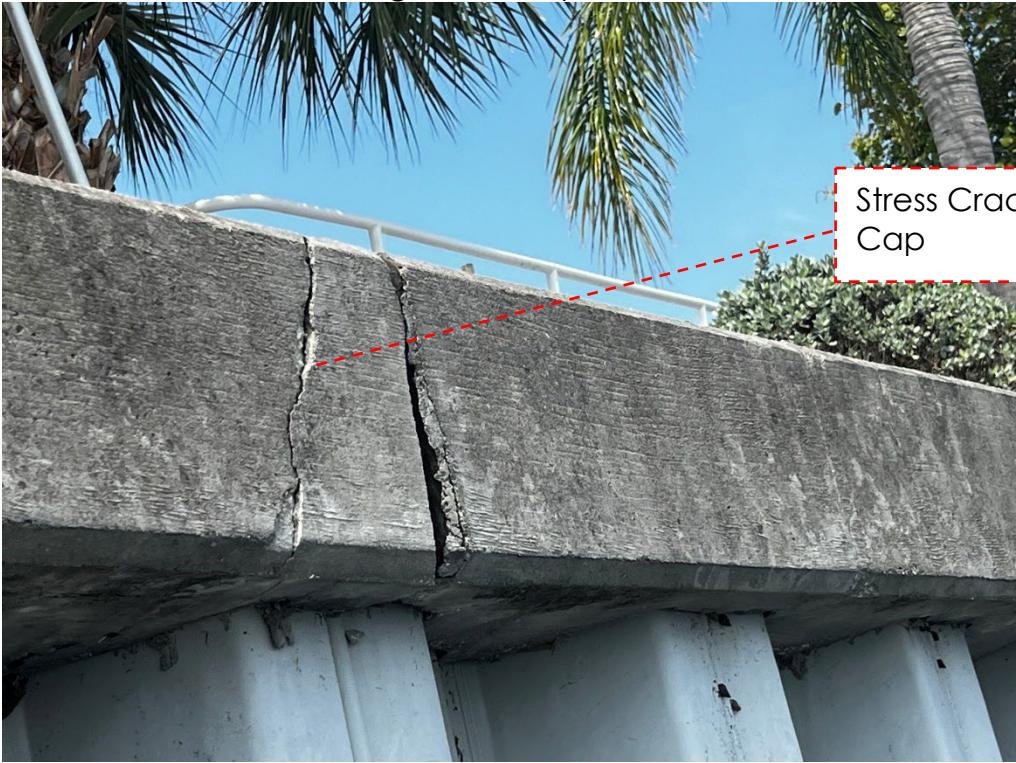
Photo #3 – Stress Cracking in the Cap.

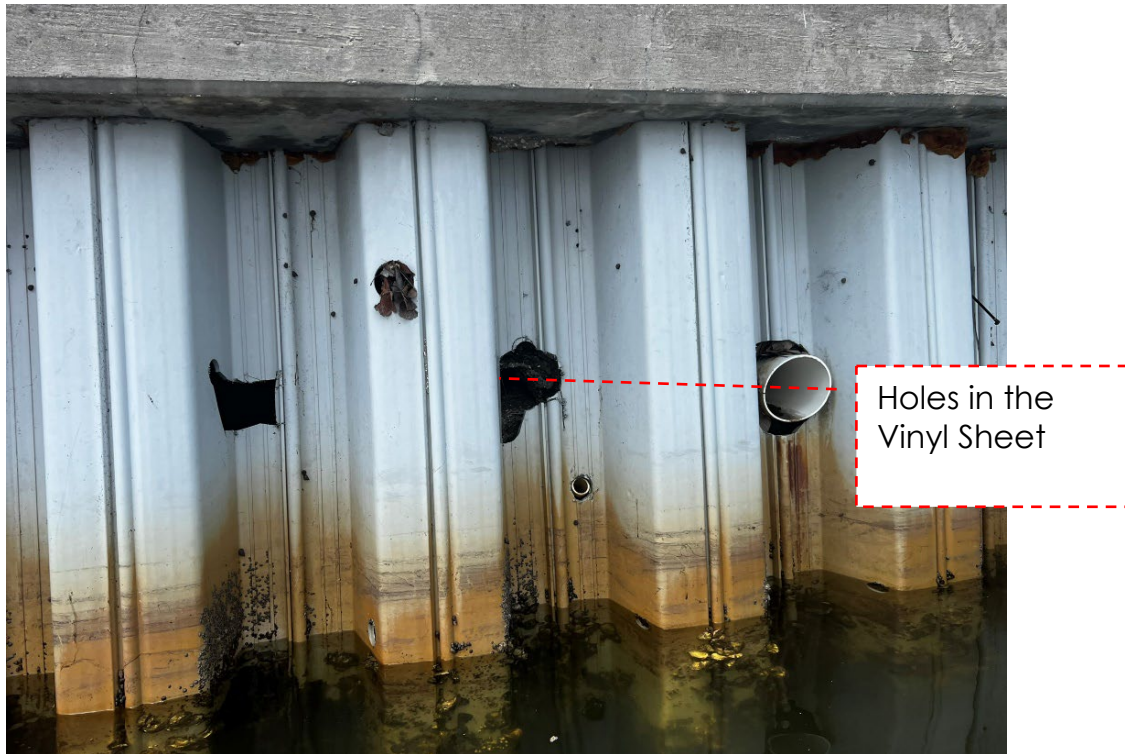
Photo #4 – Holes in the Vinyl Sheet.

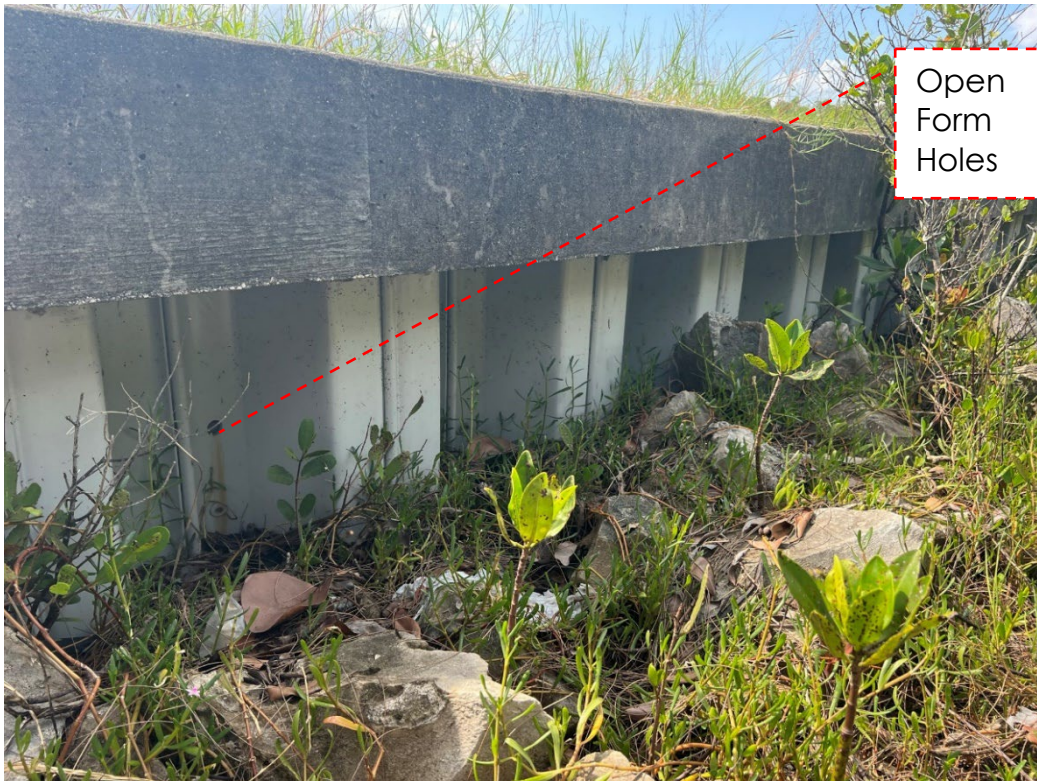
Photo #2 – Front View.

Open
Form
Holes

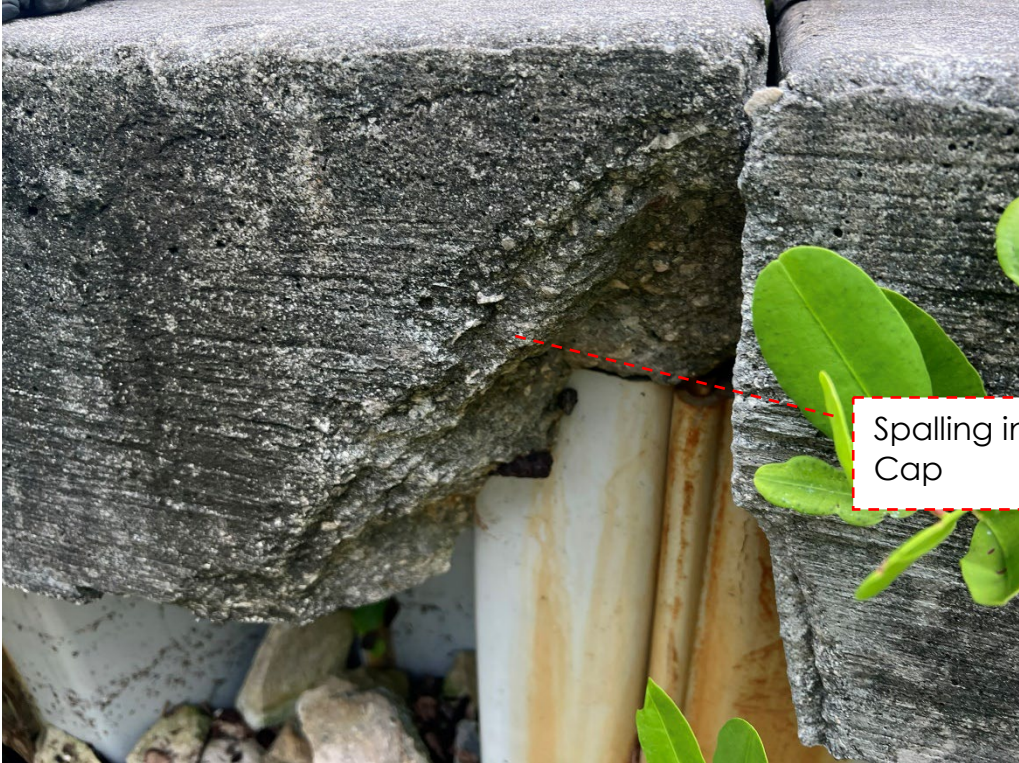
Photo #4 – Spalling in the Cap.

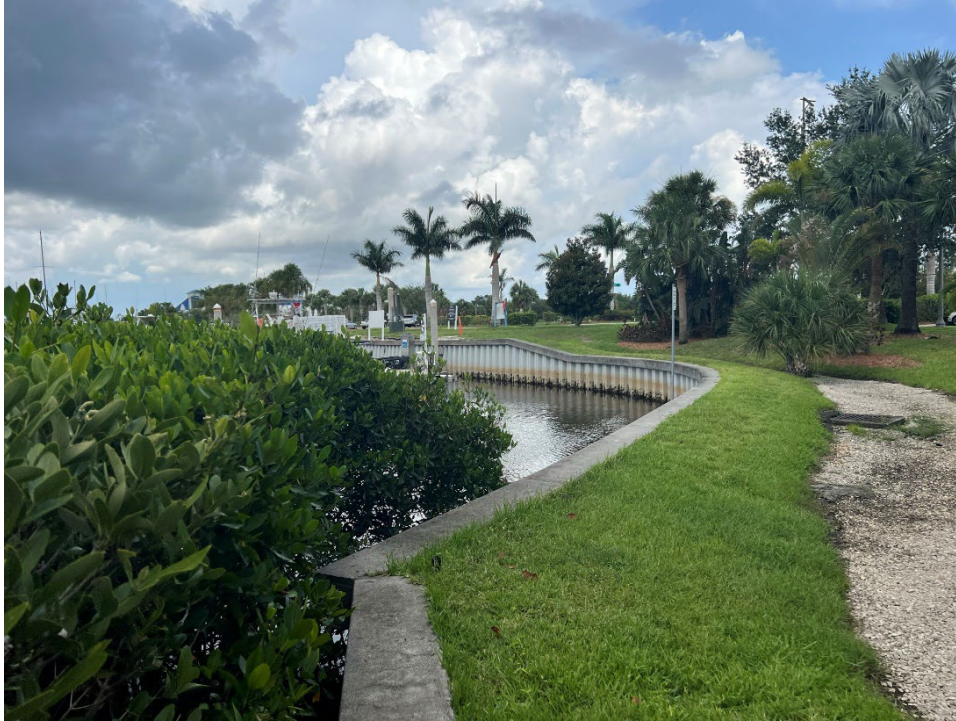
Photo #5 – Spalling in Cap. End of Section 3.

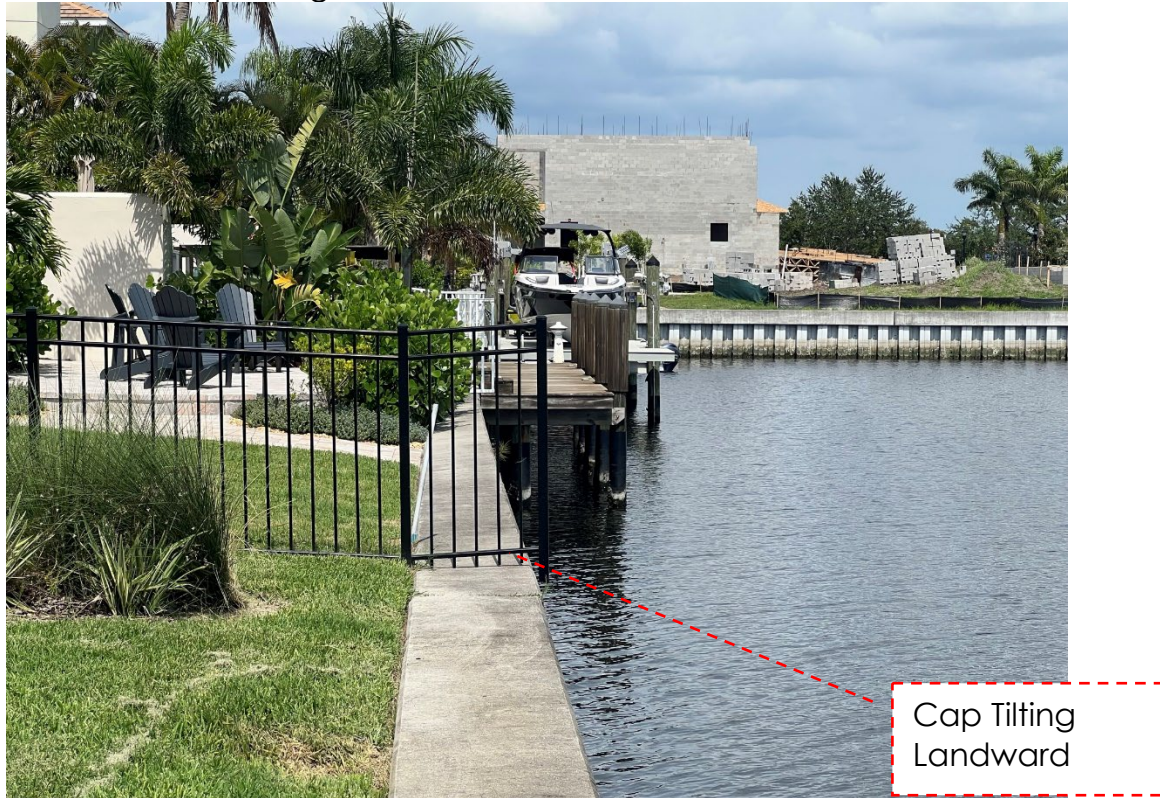
Photo #2- Cap Tilting Landward.

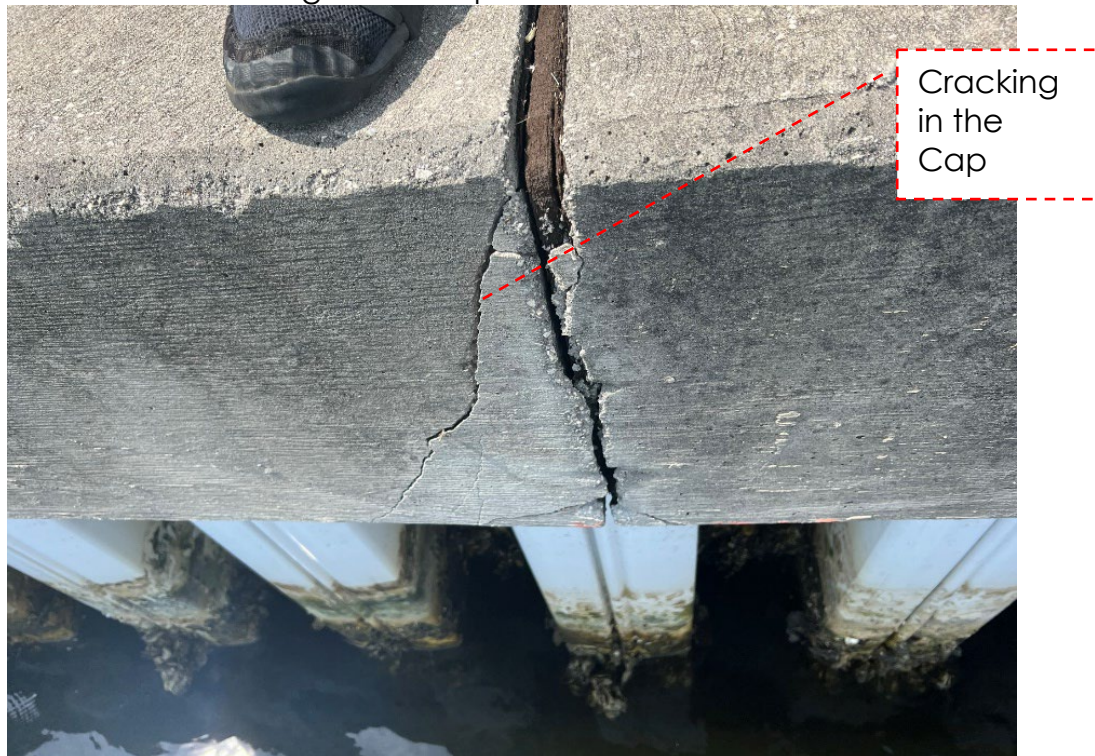
Photo #3 – Cracking in the Cap.

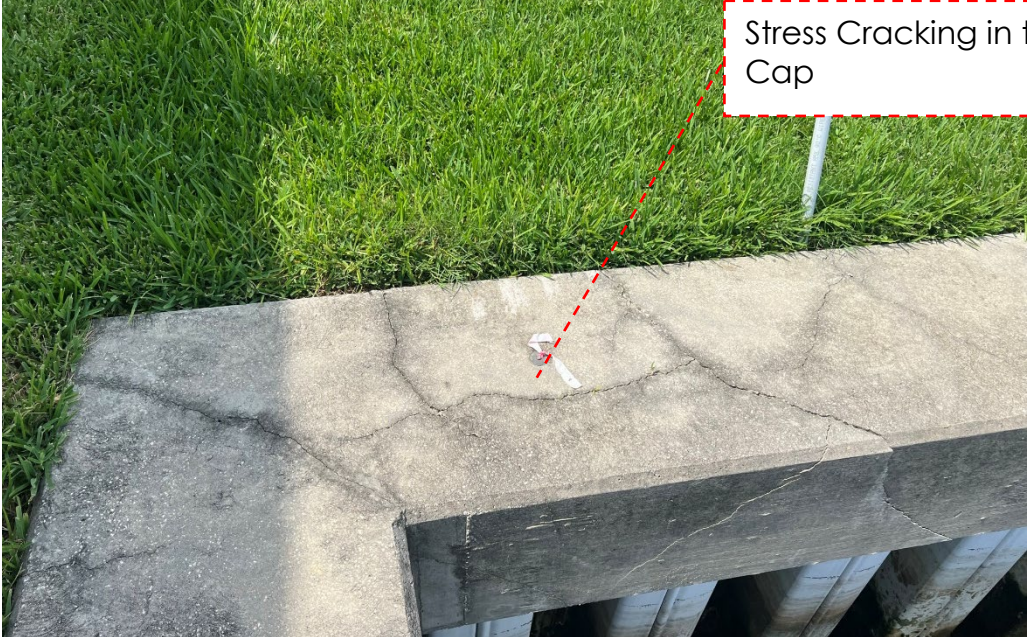
Photo #4 – Stress Cracking in the Cap.

Stress Cracking in the Cap

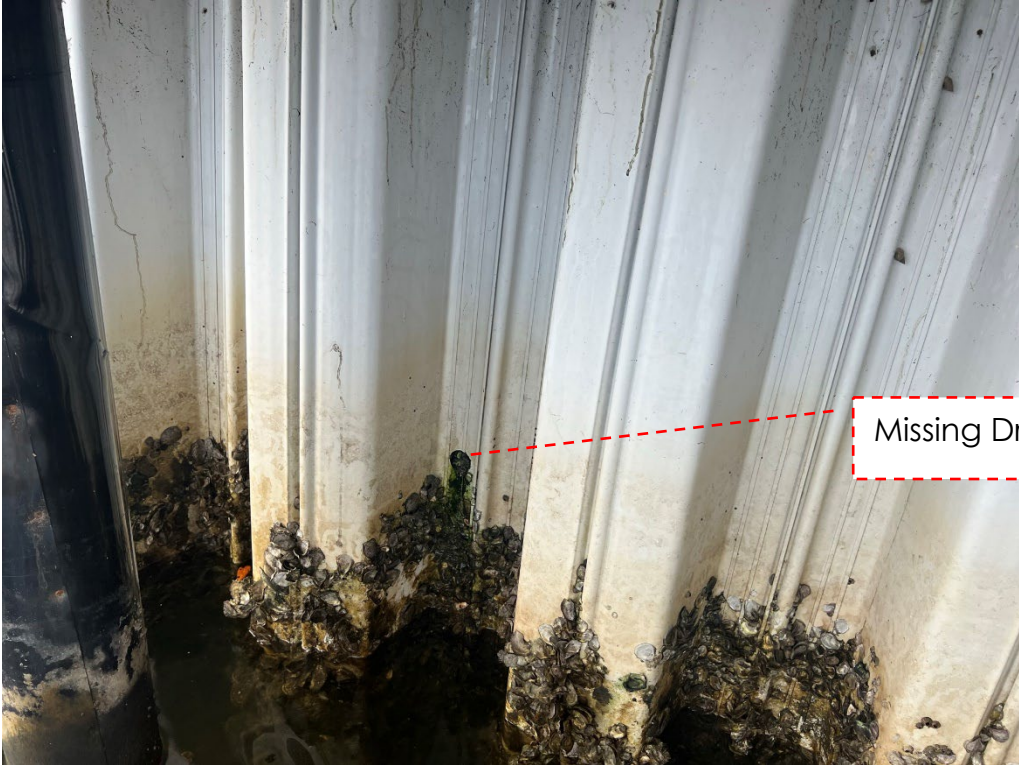
Photo #5 – Missing Drain.

Missing Drain

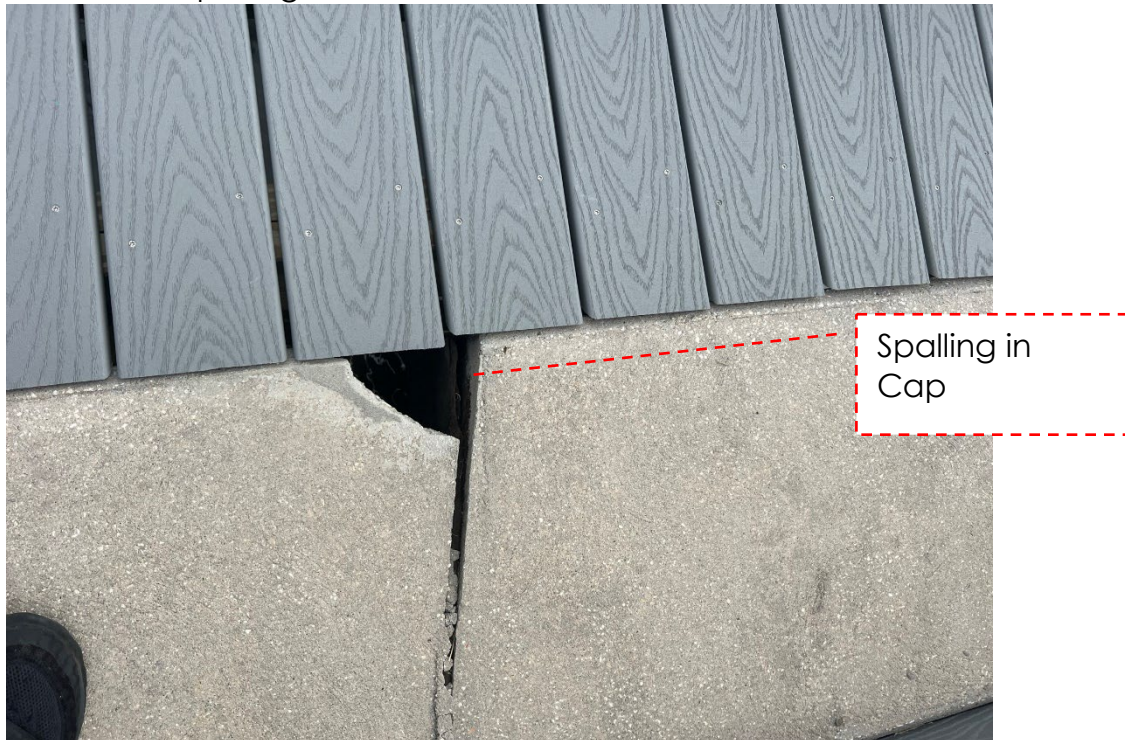
Photo #6 – Spalling.
