**Re: Seawall Inspection for Little Harbor East Marina  
3301 Sea Grape Drive, Ruskin, FL 33570**

This letter provides a summary of the field inspection performed on October 5, 2022, of the marina basin seawall located at the above referenced address. The seawall system was previously inspected by Reuben Clarson Consulting staff in October 2019. The focus of the inspection was the southern side of the marina basin with movement in the seawall reported after the Hurricane Ian storm event. The following is a summary of findings and recommendations.

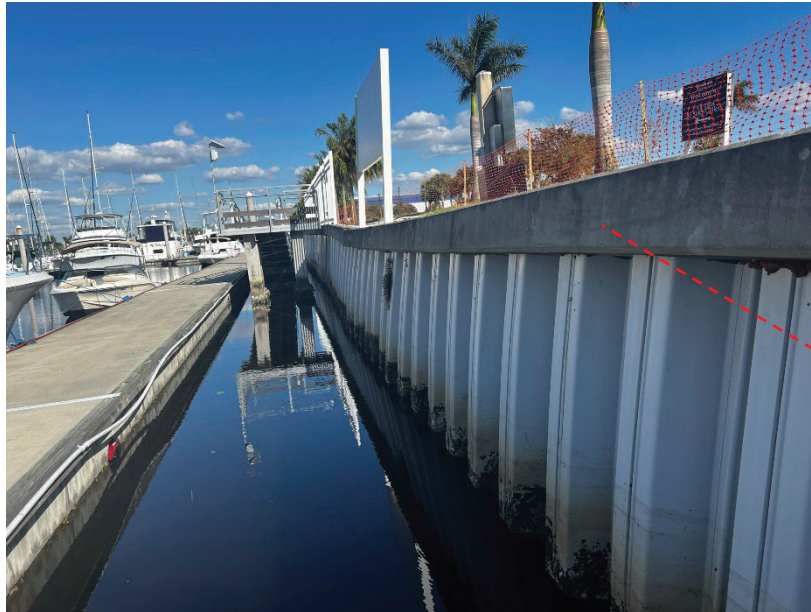
Most of the vinyl sheets were observed to be kicking out at the bottom of the wall and the sheets are bowing in areas. The concrete cap is tilted backward in many areas. Significant loss of sediment was also evident in many areas behind the seawall. Since the seawall was installed waterward of the proposed design, the depth of the water and subsequent exposed height of the

Photo #1- View of Concrete Cap of Vinyl Section Tilting Backward Looking Northeast from Southwest End of Property

Cap Rotated  
Backward

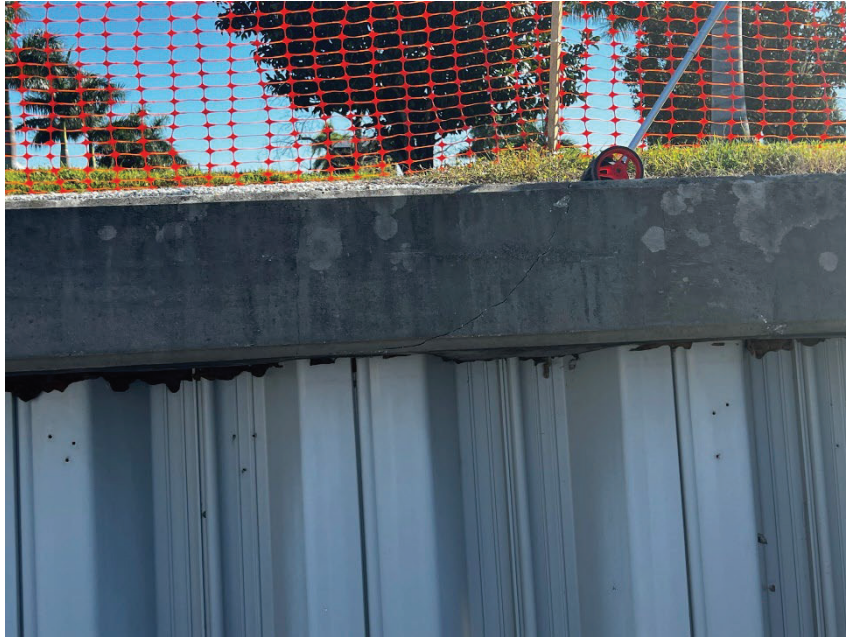
Photo #3 – Settling in Seawall Causing Disjointing in Cap

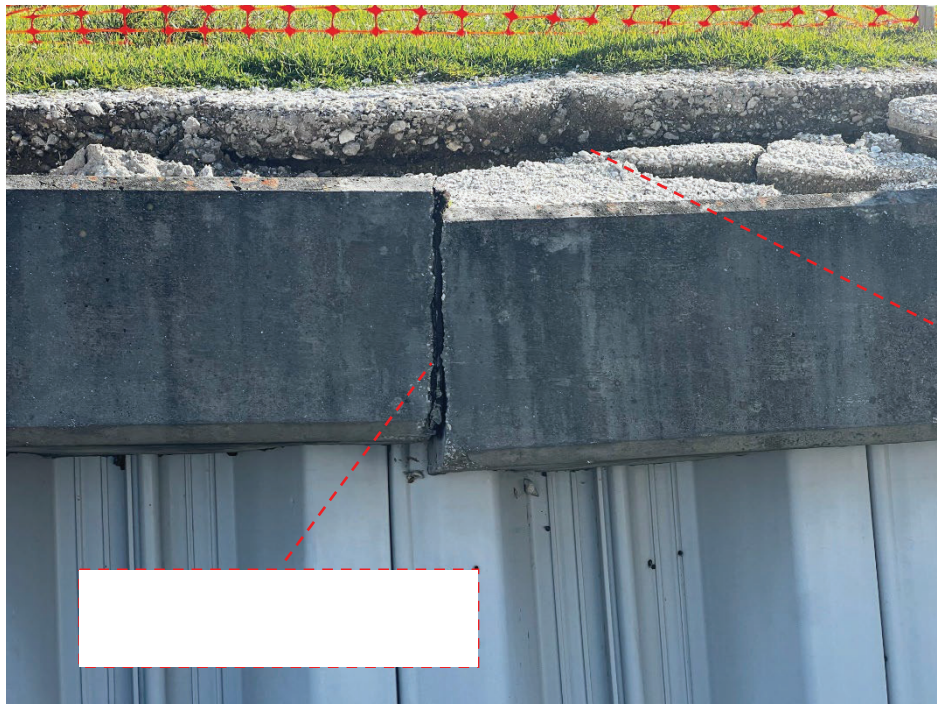
Photo #4 – View of Settling and Movement of Seawall.

Movement of Earth  
Behind Seawall

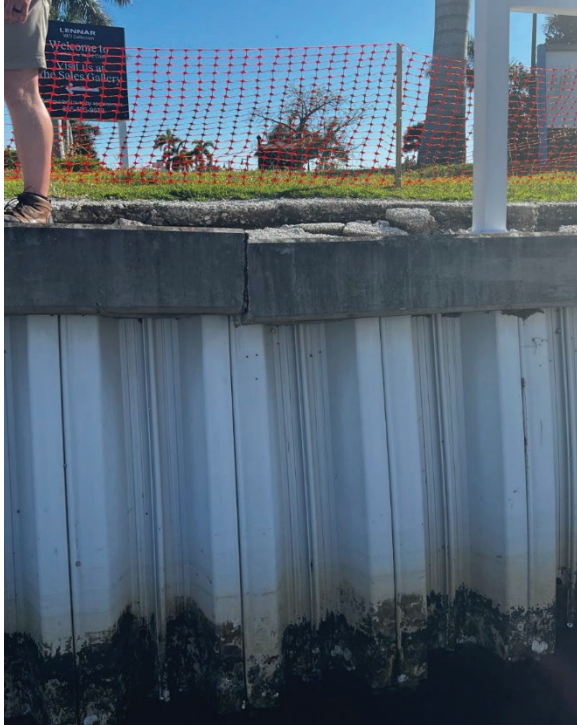
Photo #5 – View of Settling and Movement of Seawall.

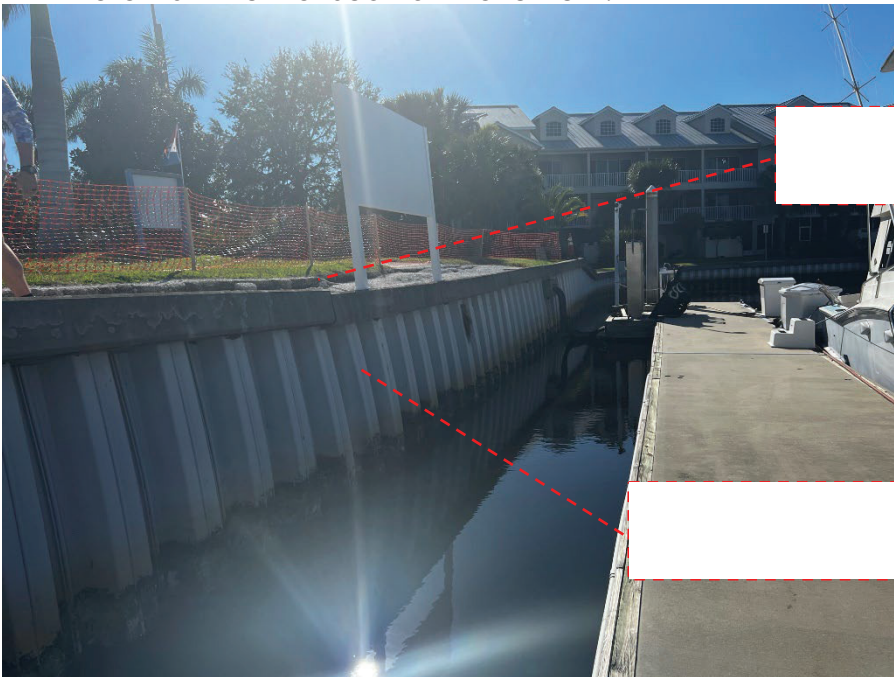
Therefore, the penetration depth in the sediment of the vinyl sheets is less than the adequate and is causing movement of the wall. The sections of the seawall that have kicked out may not be stabilized. In addition, the old concrete wall may be pushing outward on the replaced vinyl wall as sand and not concrete was filled between the two walls.

Photo #6 – View of Seawall Movement.

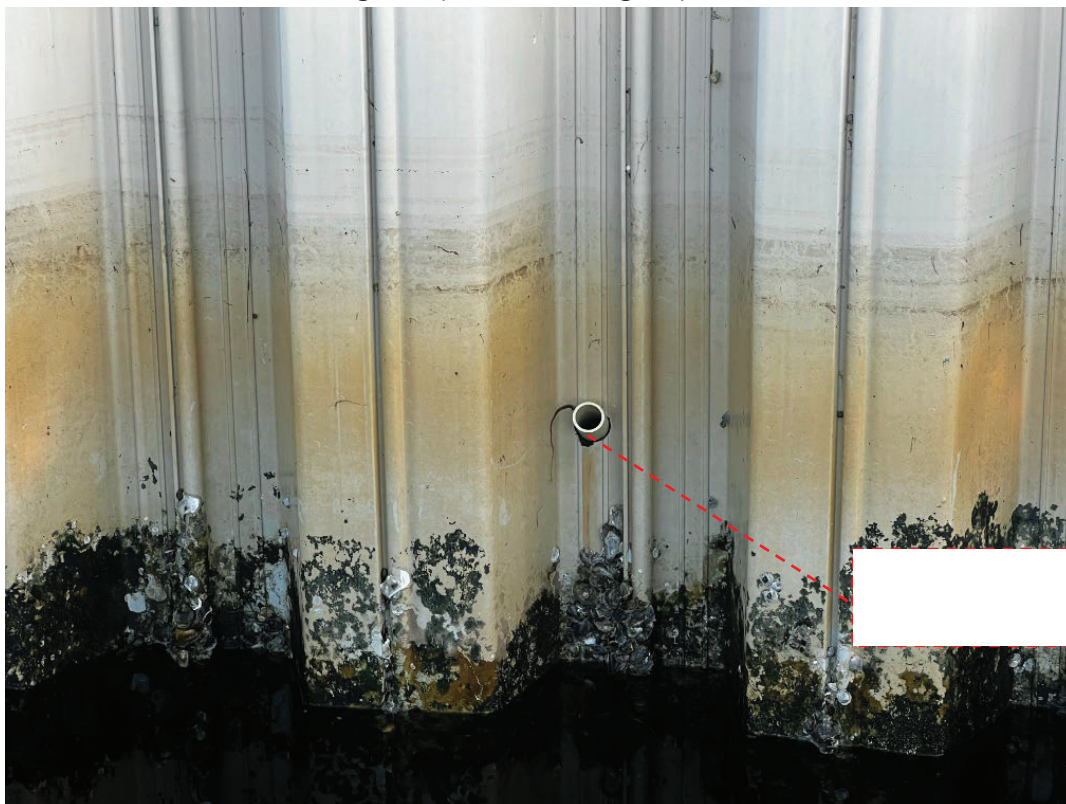
Wellpoint drains have been installed to relieve hydrostatic pressure or water from behind the seawall. However, the drains have tilted upward in areas where the wall has kicked out and may not be draining most efficiently. In some areas along the south side of the basin the wellpoint drains have become misaligned. Significant sediment loss behind the seawall was observed. Sediment is being lost through misaligned, damaged, or improperly installed wellpoint drains.

Photo #8 – View of Failing Wellpoint Drainage System.

All wellpoint drains should be replaced with new PVC slit type wellpoint drains or Jet Filter drains installed through vinyl wall at 6' on center and 5" above the barnacle line to relieve the hydrostatic pressure or aid in removing water from behind the wall. The annular area around the existing wellpoint drains and any holes should be filled with epoxy to limit sediment loss.

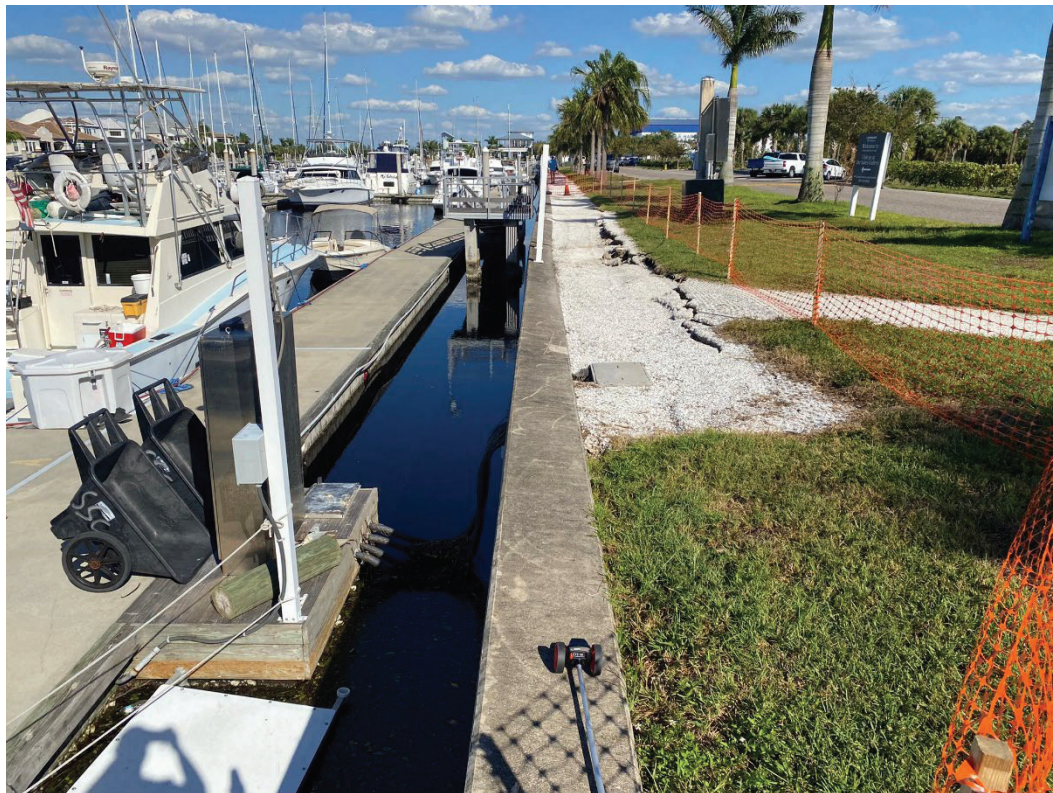
Photo #10 – Top View of Southwest End of Seawall Movement.

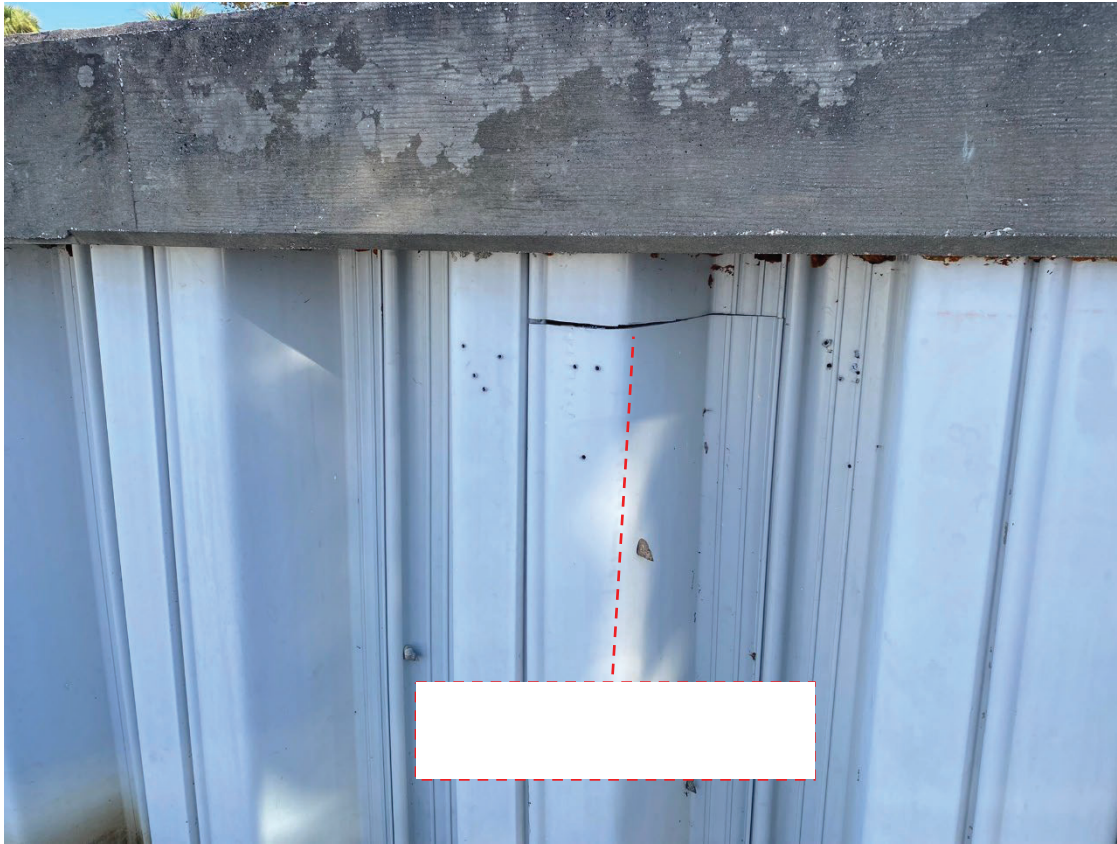
Photo #13 – View of Cut in Vinyl Sheet Pile Below Cap.

All voids behind the seawall should be filled with crushed shell or pea gravel as needed (perhaps more than once) to fill in the existing voids behind the seawall, allowing for drainage, but aid in trapping the sand particles. All cracking in the seawall cap areas should be chipped, cleaned, and filled with hydraulic cement or epoxy. Epoxy repair cut vinyl sheets to prevent sediment loss and aid in structural strength of the sheet pile.

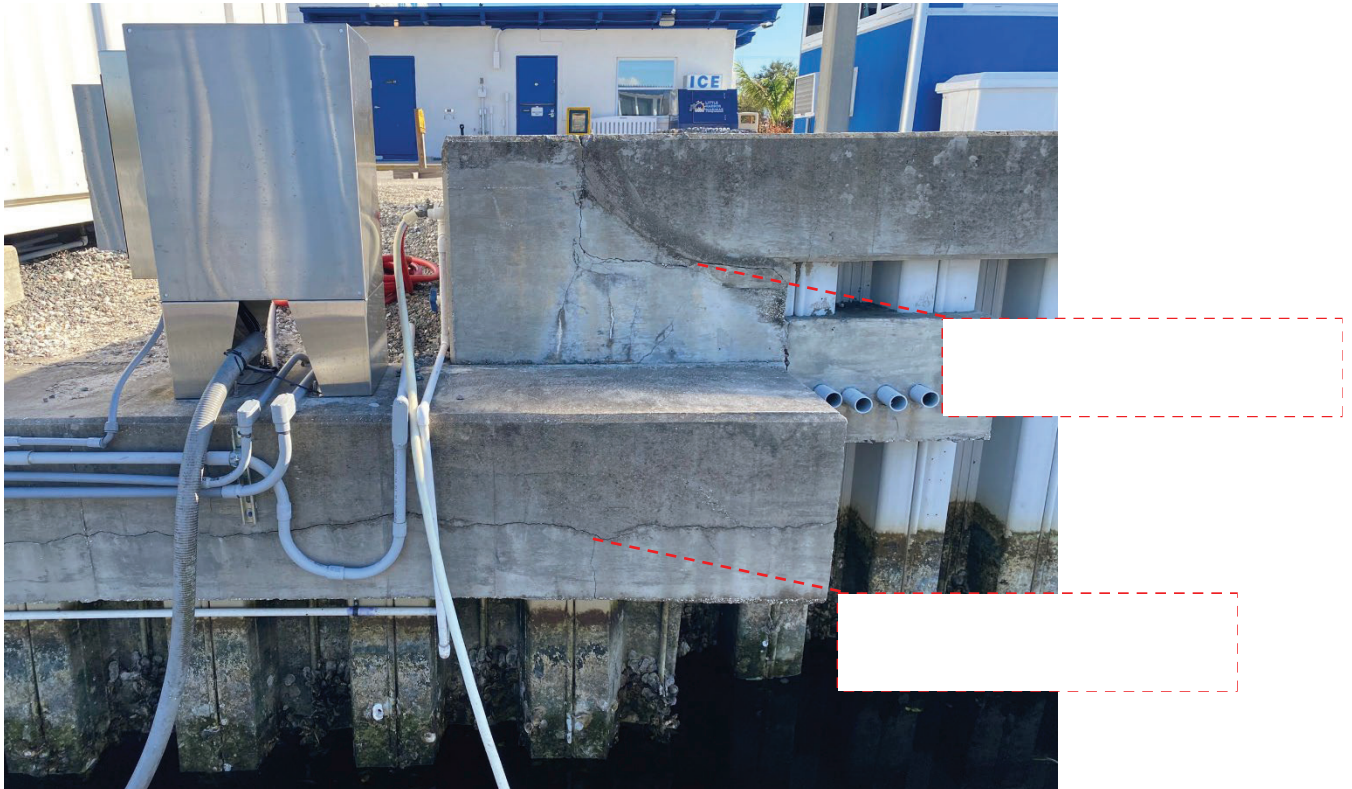
Most of the southern portion of the seawall cap is in good condition. Although, structural defects (horizontal cracking) in the front face of the seawall cap were observed by the marina loading area indicating the rebars inside the concrete are rusting from salt intrusion. The rusting causes the rebars to expand and thus crack the concrete. Shear cracking of the concrete cap due to movement of the seawall was also observed along the southern side of the basin.

Photo #14 – View of Longitudinal Cracking in Seawall Cap.

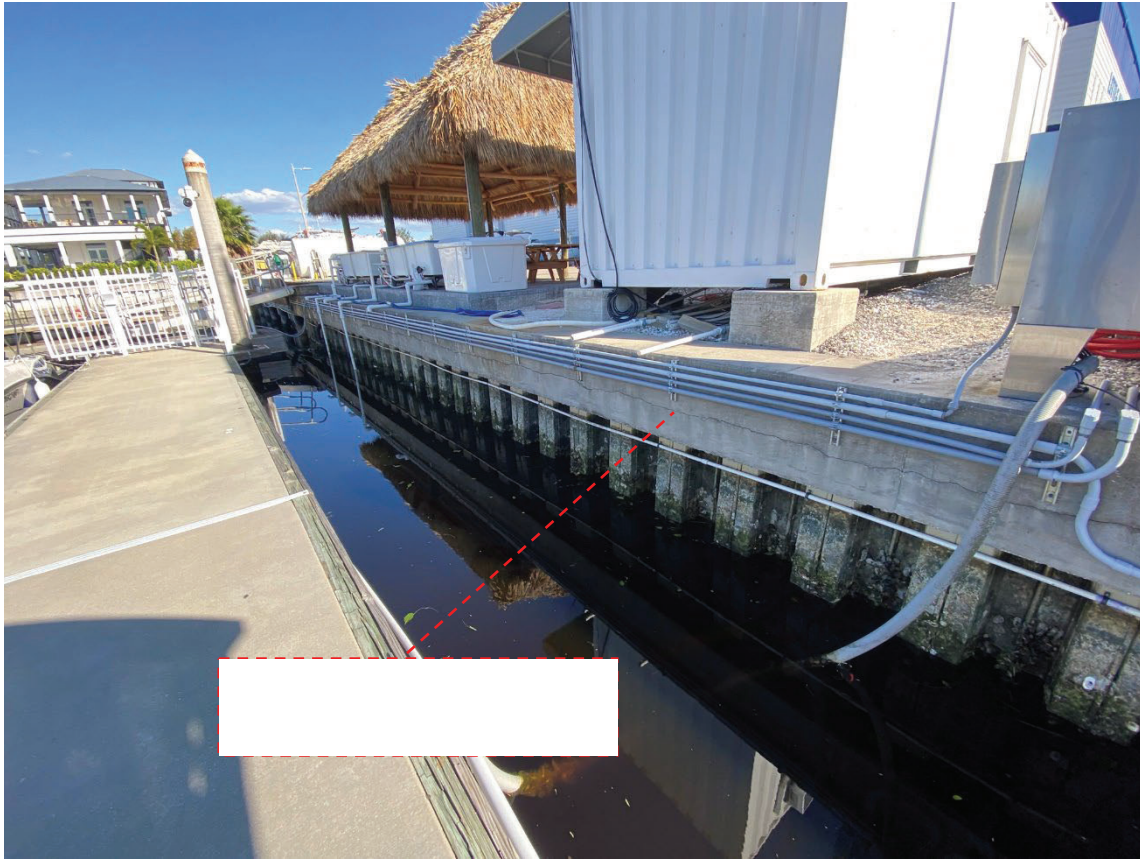
Photo #15 – Longitudinal Cracking in Seawall Cap.

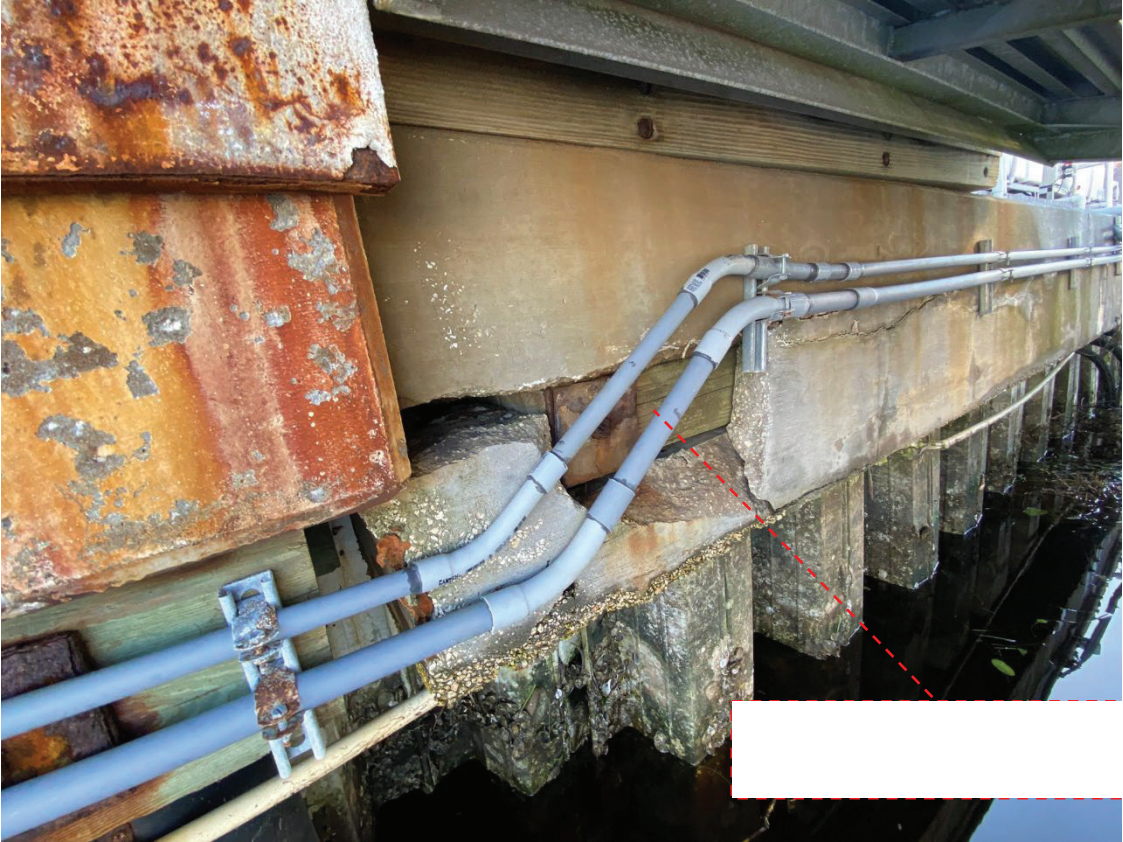
1086' to 1090'	24" x 27"	Vinyl	102"	<ul style="list-style-type: none"> <li>Cap (Wrap cap) split apart revealing it is a concrete wrap cap over top of a wooden waler with tieback rods running through it.</li> </ul>
1090'	25" x 44"	Vinyl	102"	<ul style="list-style-type: none"> <li>End of lower wall.</li> </ul>
1130'	25" x 44"	Vinyl	102"	<ul style="list-style-type: none"> <li>Piling supported wall.</li> </ul>
1130' to 1204'	25" x 44"	Vinyl	102"	<ul style="list-style-type: none"> <li>Newer secondary anchors installed in this area (8).</li> <li>Wood waler evident.</li> </ul>

Photo #17 – View of Spalling in Wrap Cap.
