January 15, 2020

**Re: Seawall Inspection for Little Harbor East Marina
3301 Sea Grape Drive, Ruskin, FL 33570**

RE: Seawall Inspection Report – Little Harbor East Marina, 3301 Sea Grape Dr, Ruskin, FL

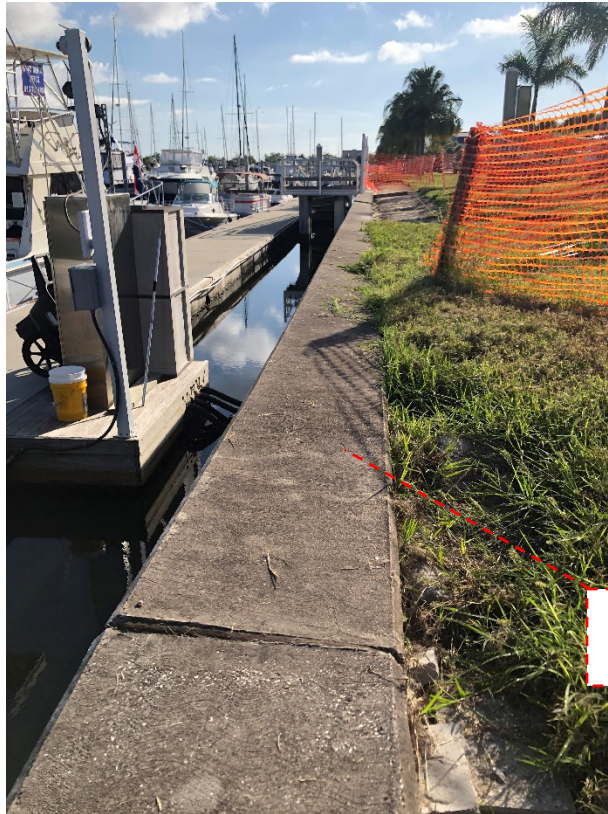
Most of the vinyl sheets were observed to be kicking out at the bottom of the wall and the sheets are bowing in areas. The concrete cap is tilted backward in many areas. Significant loss of sediment was also evident in many areas behind the seawall. Since the seawall was installed waterward of the proposed design, the depth of the water and subsequent exposed height of the seawall is greater than was anticipated in the vinyl seawall replacement design.

Photo #1- View of Concrete Cap Tilting Backward Looking Northeast from Southwest End of property

Cap Rotated
Backward

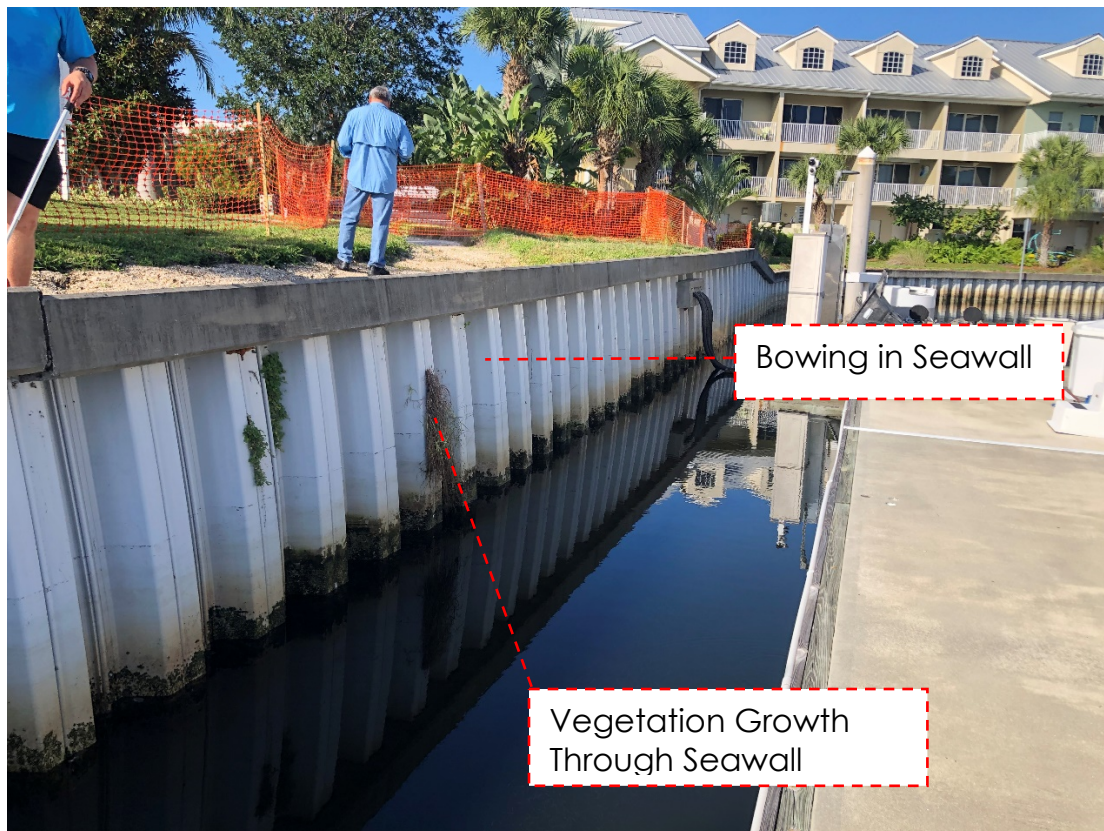
Photo #2 – View Looking Southwest from the Southwest End of property

Bowing in Seawall

Vegetation Growth
Through Seawall

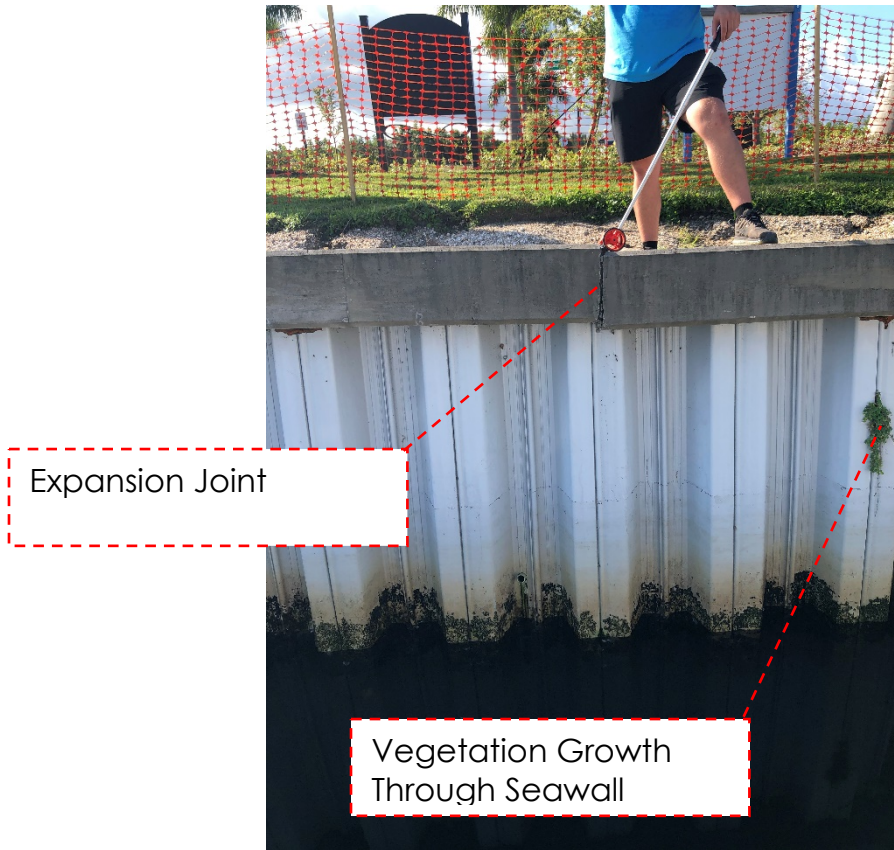
Photo #3 – Settling in Seawall Causing Movement in Cap

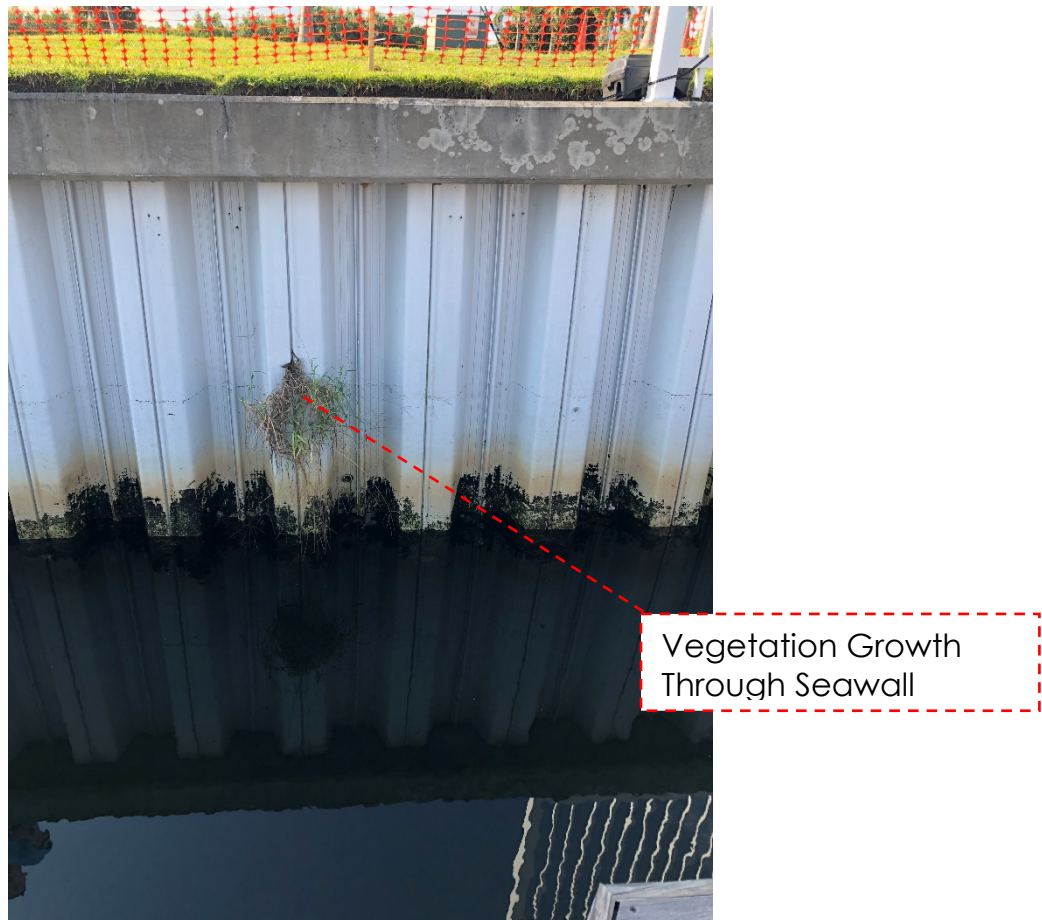
Photo #4 – View of Vegetation Growth Through Seawall

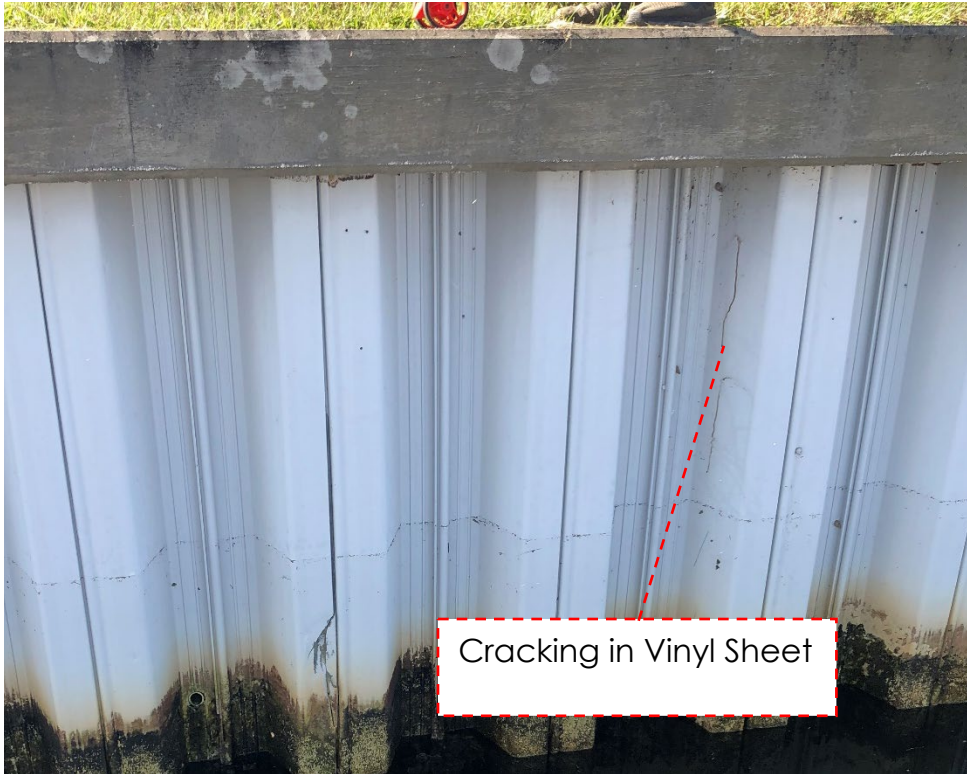
Photo #5 – View of Vertical Cracking at Top of Vinyl Sheet

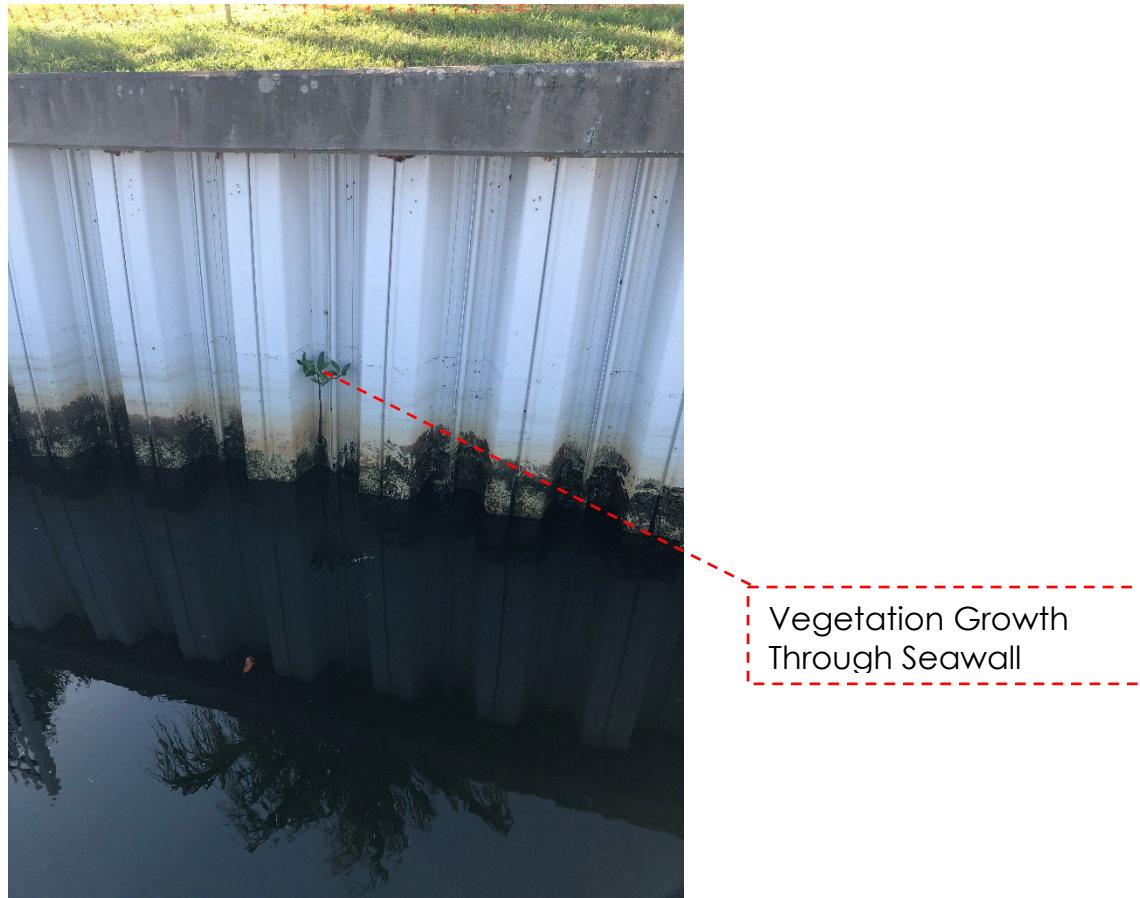
Photo #6 – View of Vegetation Growth Through Seawall

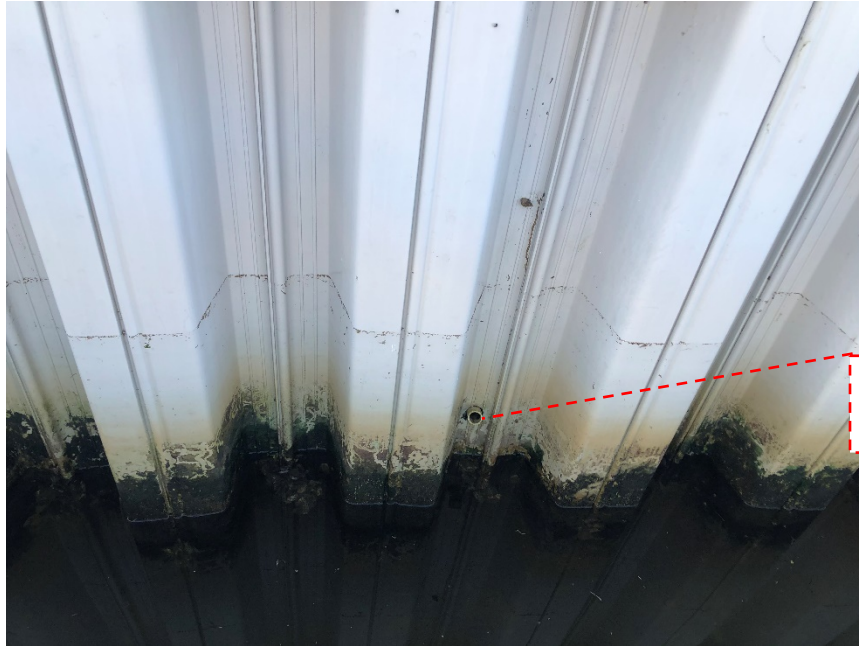
Wellpoint drains have been installed to relieve hydrostatic pressure or water from behind the seawall. However, the drains have tilted upward in areas where the wall has kicked out and may not be draining most efficiently. In some areas along the north side of the basin the wellpoint drains have become misaligned. Significant sediment loss behind the seawall was observed on both the north and south sides of the basin. Sediment is being lost through misaligned, damaged or improperly installed wellpoint drains.

Photo #7 – WellPoint Drain Mismatched in Vinyl Sheet

Drain Tilting Upward

Any broken or misaligned wellpoint drains should be replaced with new drains installed through both walls at 6' on center and 5" above the barnacle line to relieve the hydrostatic pressure or aid in removing water from behind the wall. The annular area around the existing wellpoint drains and any holes should be filled with epoxy to limit sediment loss.

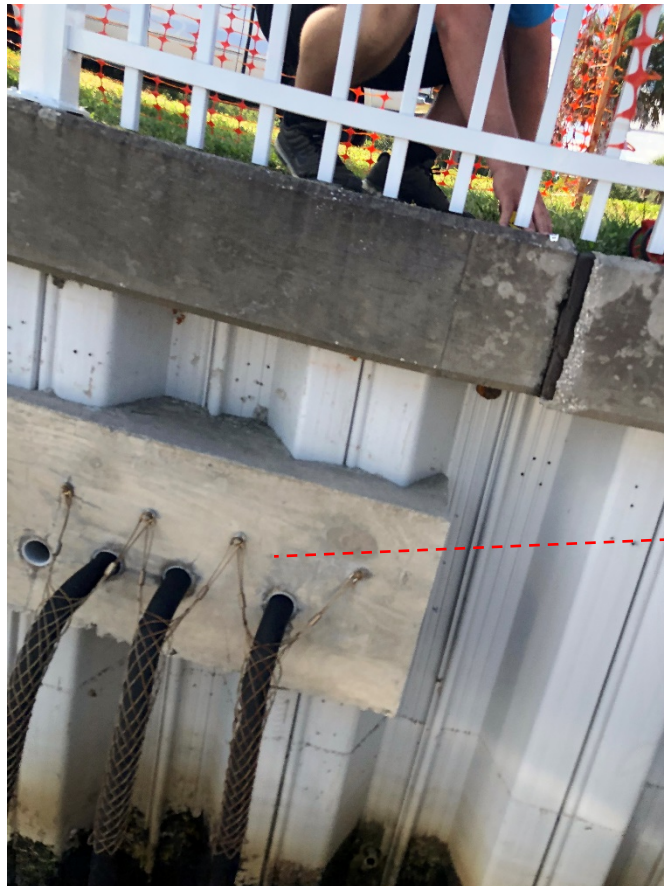
Photo #8 – Sediment Loss at FDC Connection and Tieback Exposed

FDC Connection

All voids behind the seawall should be filled with crushed shell or pea gravel as needed (perhaps more than once) to fill in the existing voids behind the seawall, allowing for drainage, but aid in

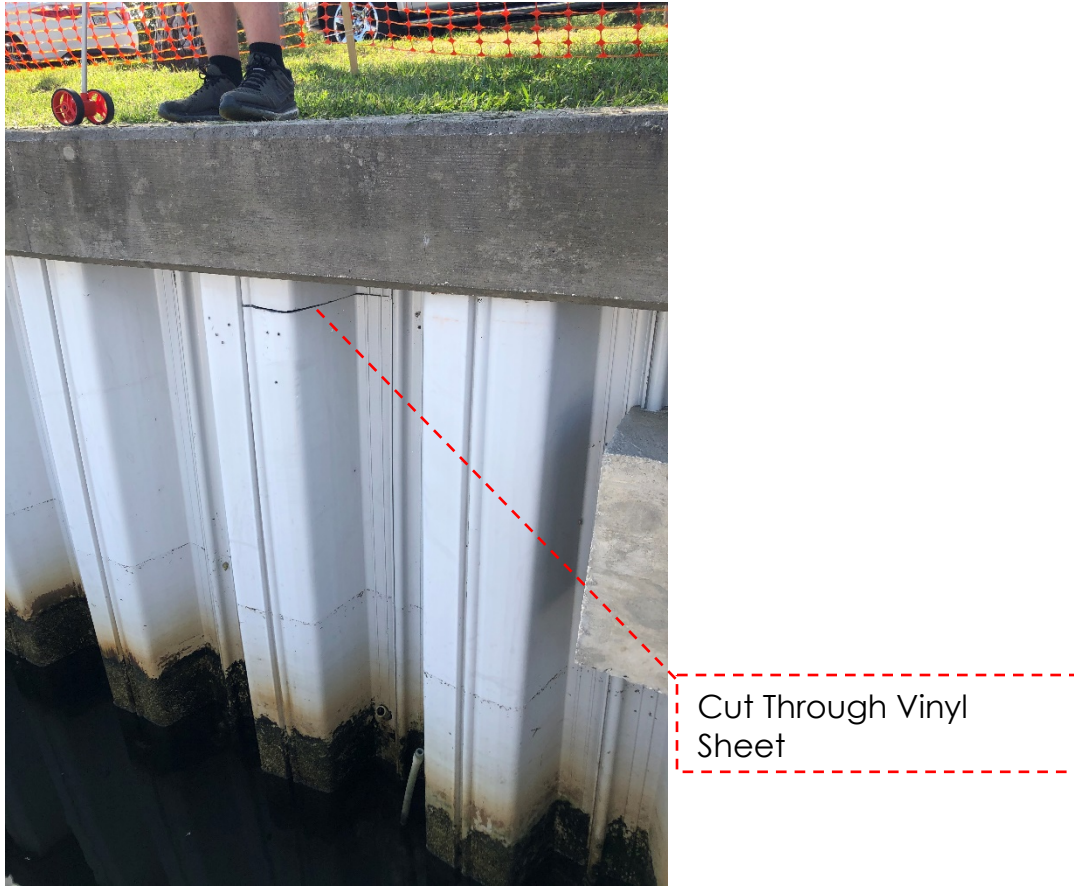
Photo #9 – Vinyl Sheet Cut at Top of Sheet

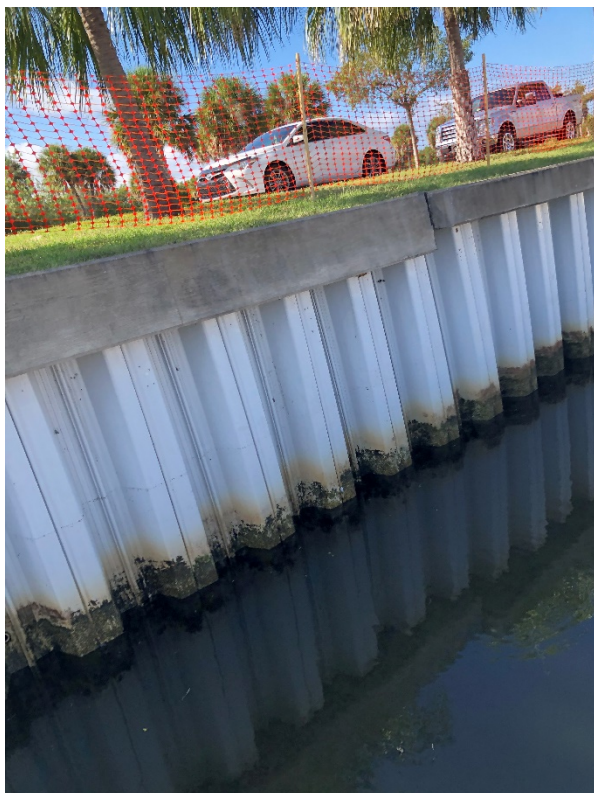
Photo #10 – View of Seawall Cap Change and Cap (Right Cap in Photo) Alignment Out 4 Inches

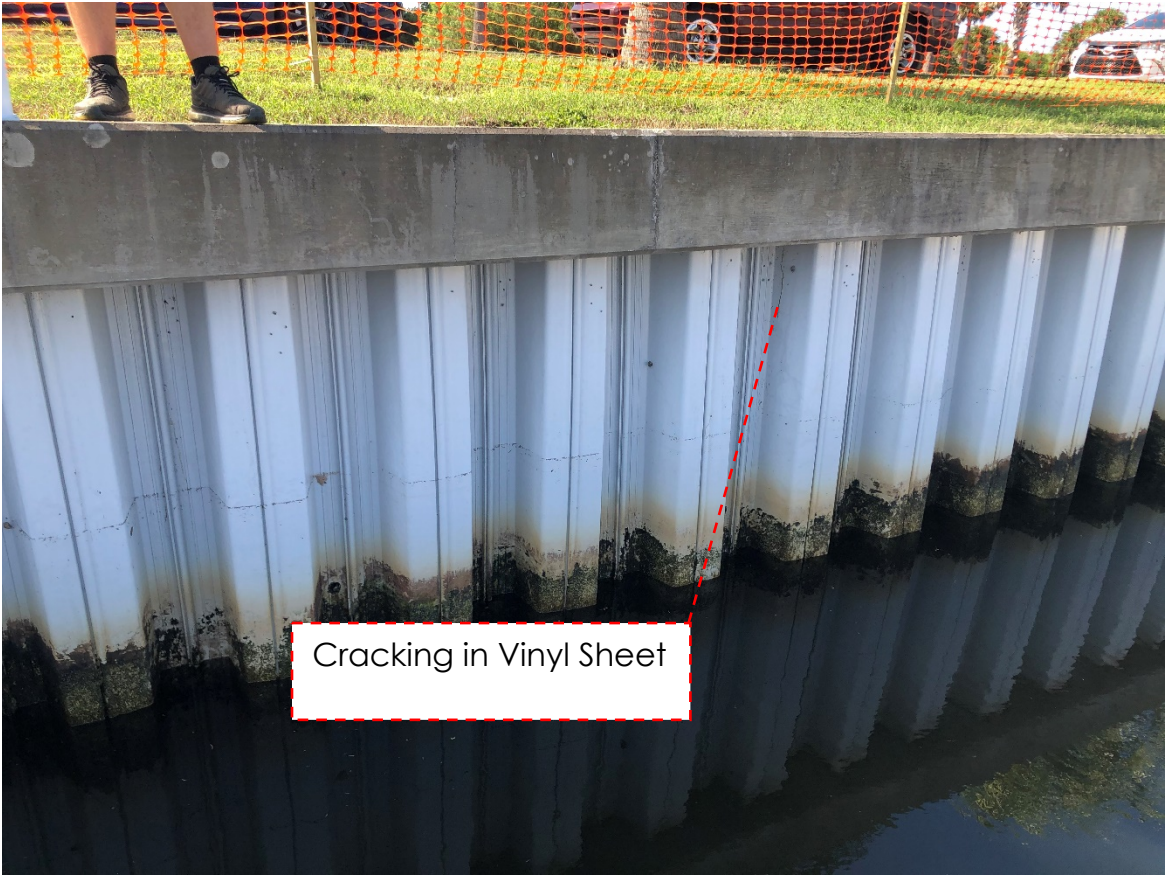
Photo #11 – View of Vertical Cracking at Top of Vinyl Sheet

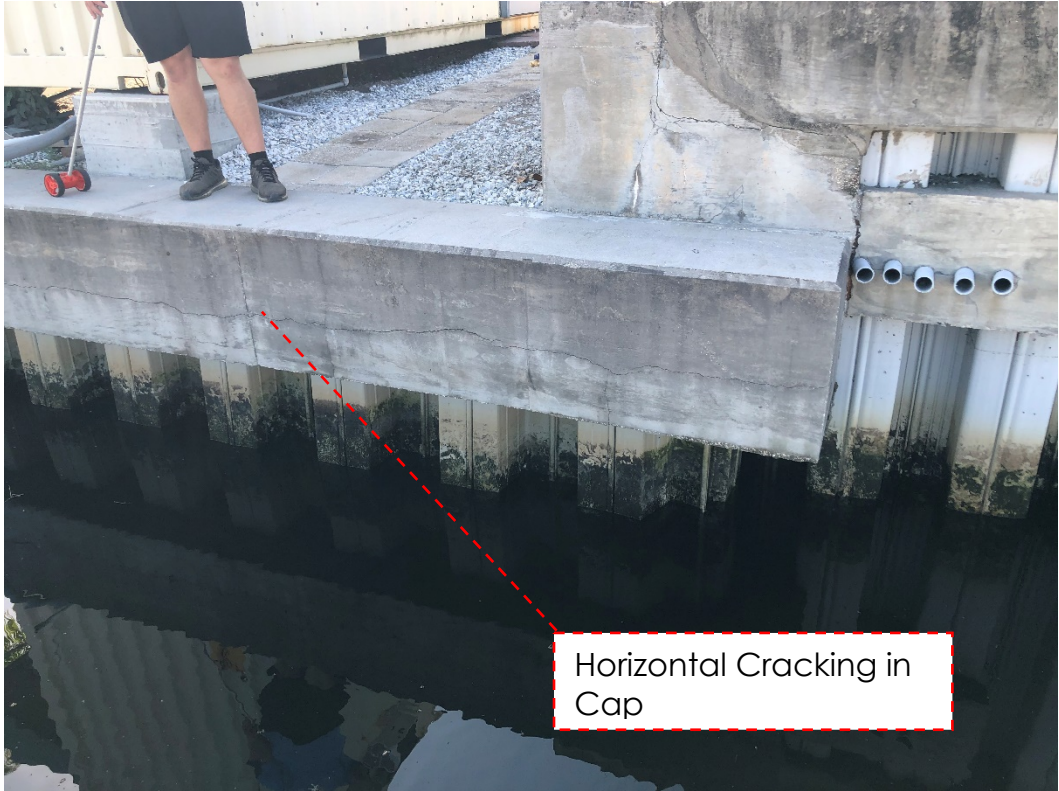
Most of the southern portion of the seawall cap is in good condition. Although, structural defects (horizontal cracking) in the front face of the seawall cap was observed by the marina loading area indicating the rebars inside the concrete are rusting from salt intrusion. The rusting causes the rebars to expand and thus crack the concrete. Horizontal cracking and spalling of the cap were observed in several areas along seawall at the northern side of the marina basin with previous concrete repairs evident in some locations. Shear cracking of the concrete cap due to movement of the seawall was also observed along the northern edge of the basin.

Photo #12 – View of Horizontal Cracking in Seawall Cap

trapping the sand particles. All cracking in the seawall cap areas should be chipped, cleaned and filled with hydraulic cement or epoxy.

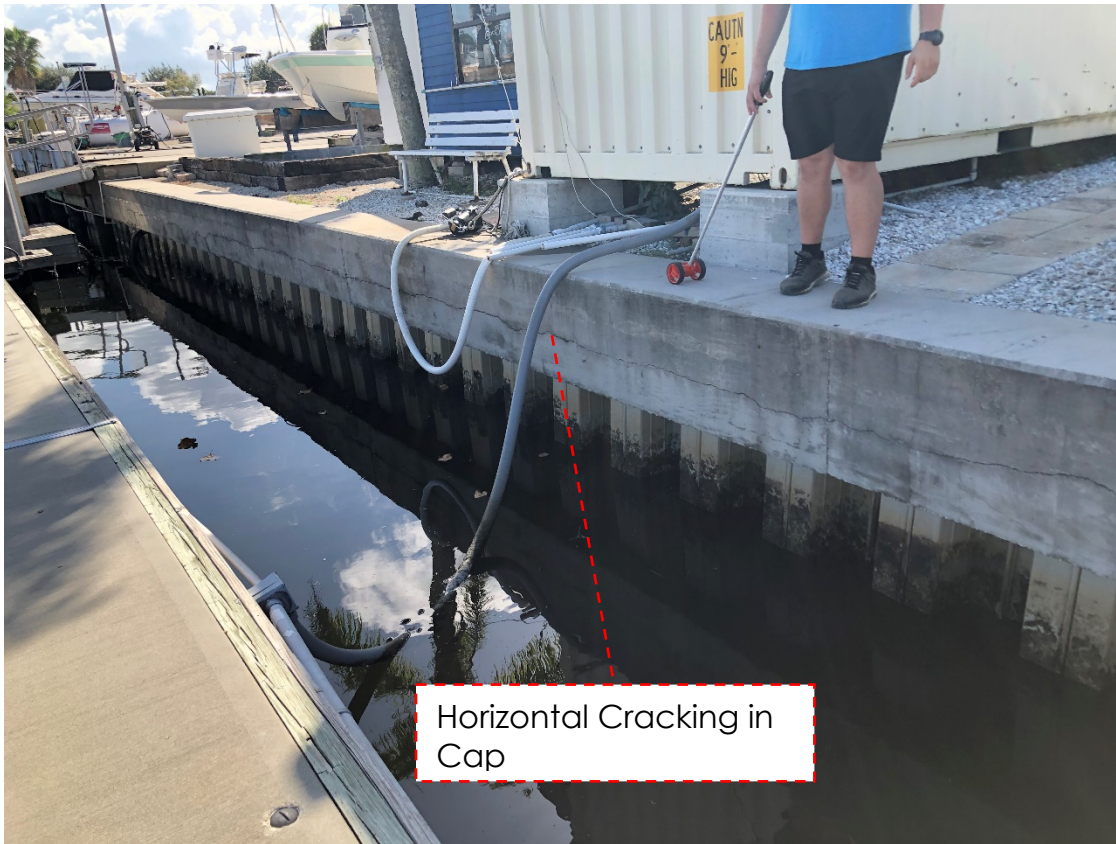
Photo #13 – View of Horizontal Cracking in Seawall Cap

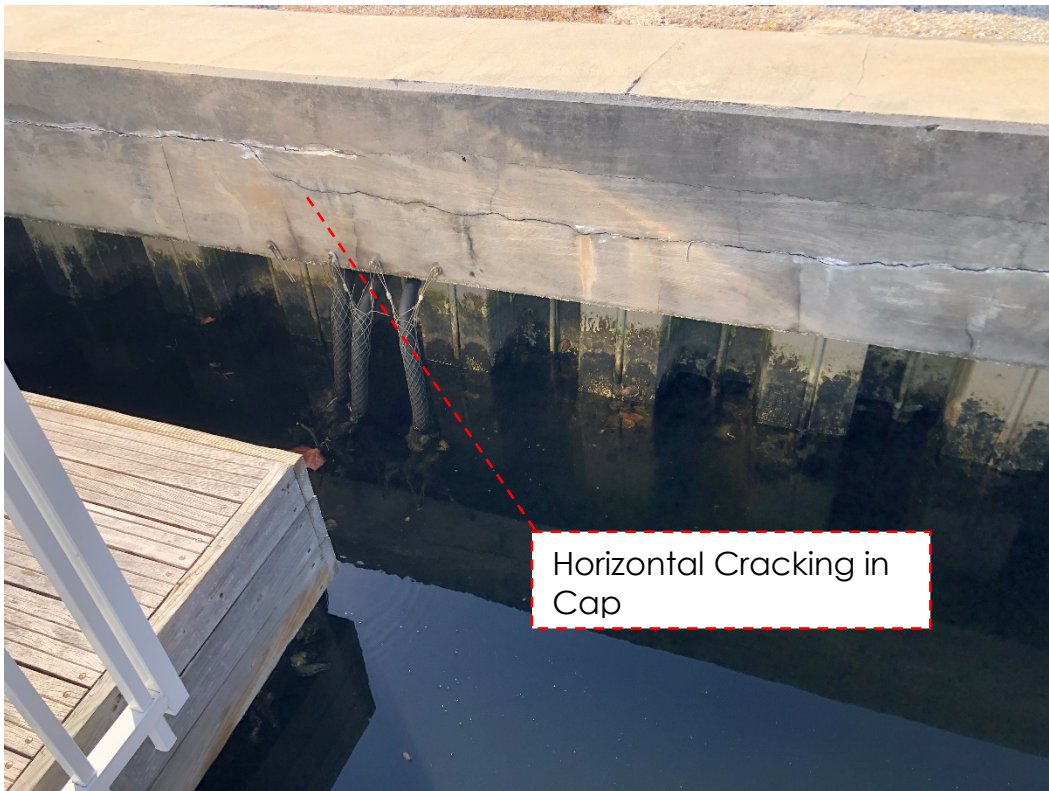
Photo #14 – View of Horizontal Cracking in Seawall Cap

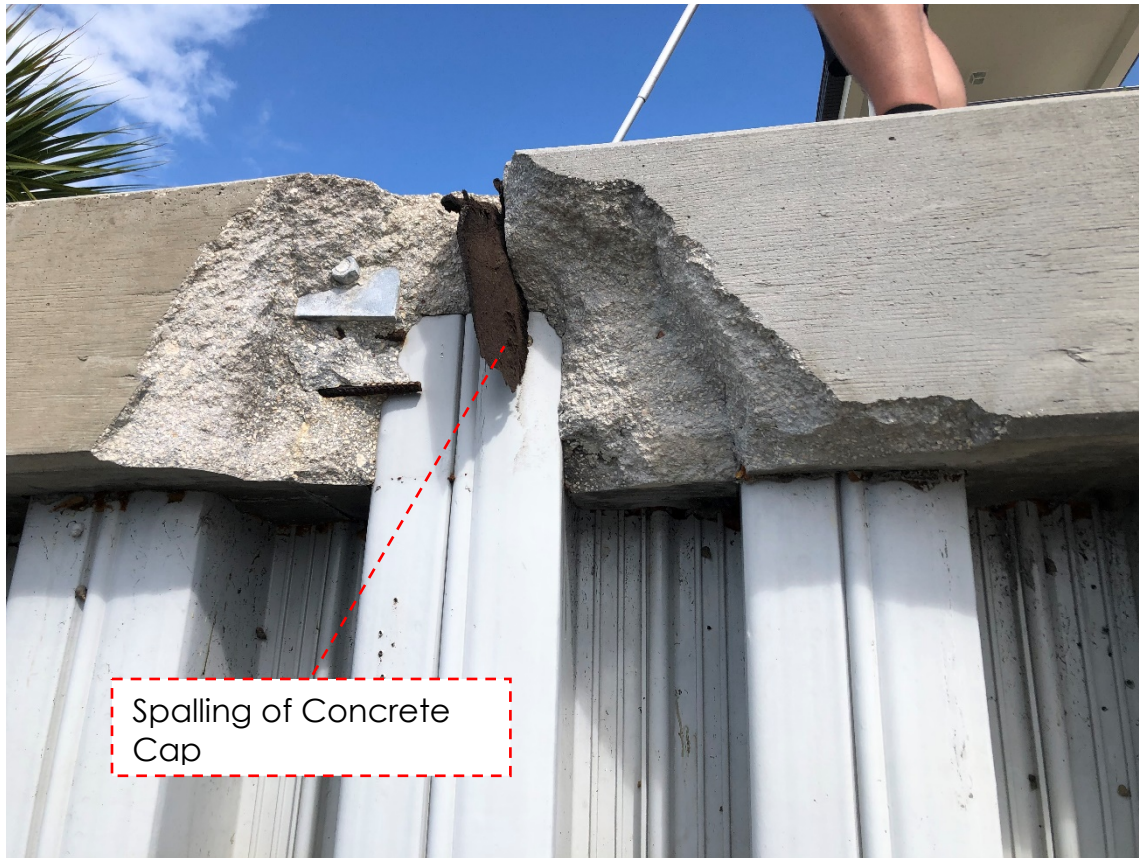
Photo #15 – Spalling Section of Seawall Cap

Spalling of Concrete
Cap

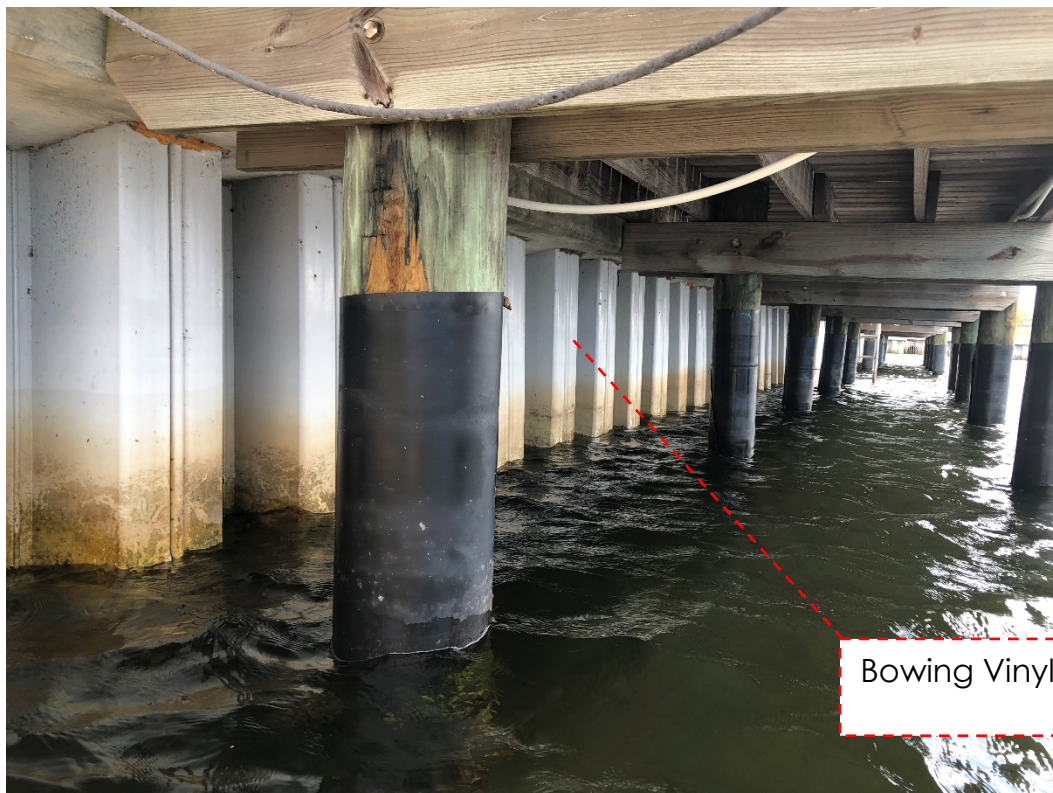
Photo #16 – View of Bowing Vinyl Sheets Underneath Docks

Bowing Vinyl Sheets

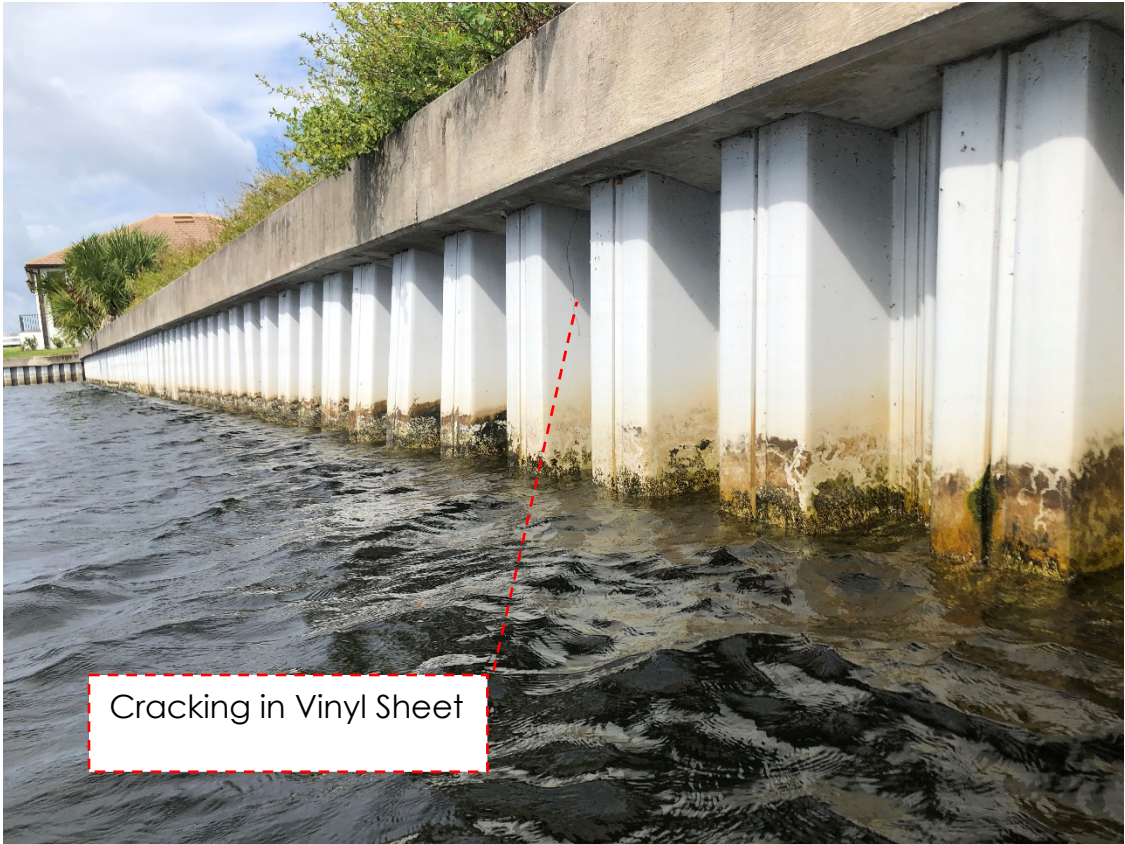
Photo #17 – Vertical Cracking at Top of Vinyl Sheet

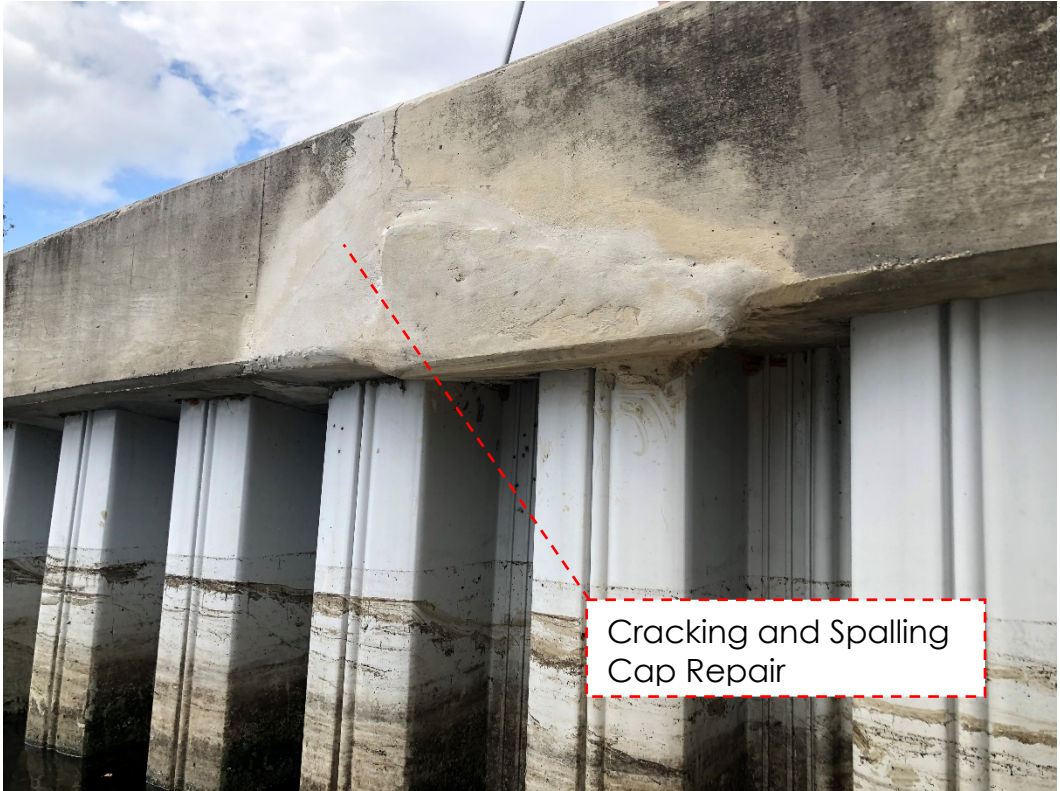
Photo #18 – Repaired Section of Spalling in Cap

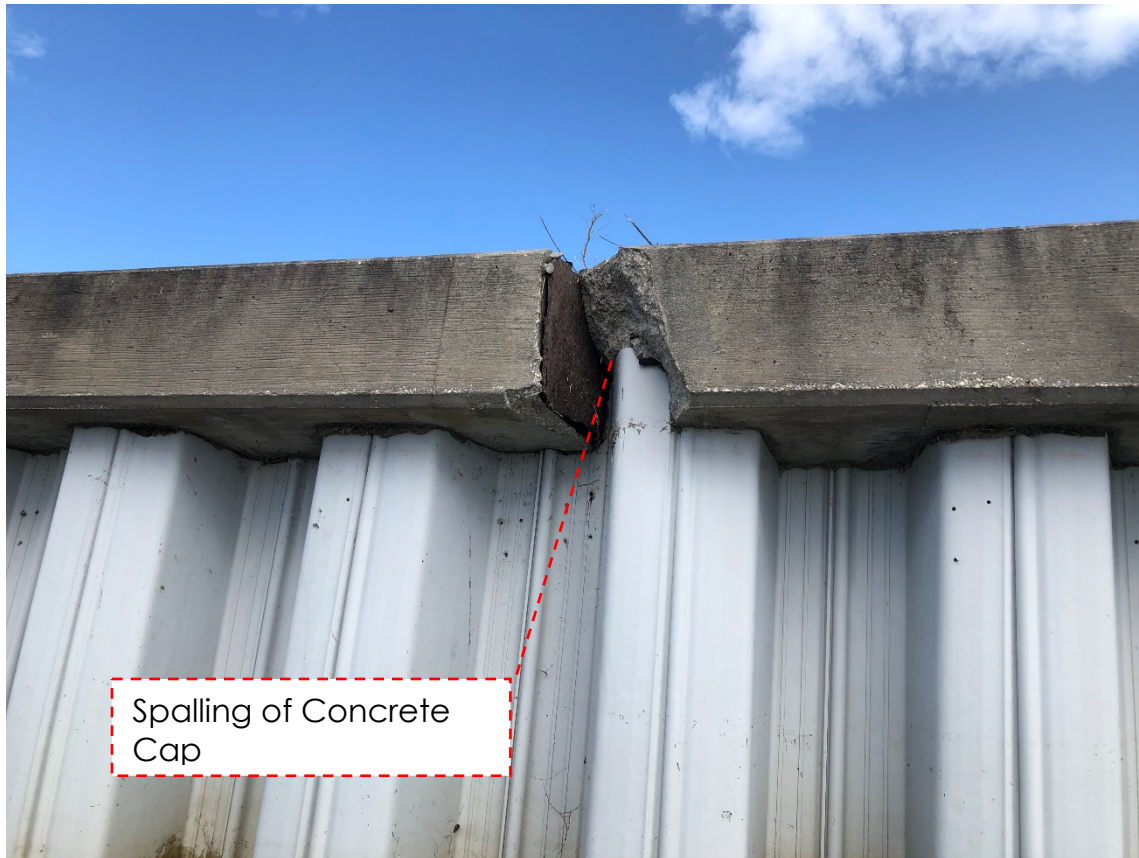
Photo #19 – Spalling Section of Seawall Cap at Expansion Joint
