July 12, 2023

**Re: Seawall Inspection for Little Harbor Marina/South Bay CDD
606 Seagrape Dr, Ruskin, FL 33570**

This letter provides a summary of the field inspection performed on various dates throughout 2023 of the seawalls within the bounds of the South Bay Community Development District. The Little Harbor Marina basin was recently inspected in October 2022 with conclusions and recommendations for maintenance and repairs provided (Reuben Clarson Consulting, October 20, 2022). This previous seawall section of the Little Harbor Marina basin has been excluded from this report. The following is a summary of findings and recommendations.

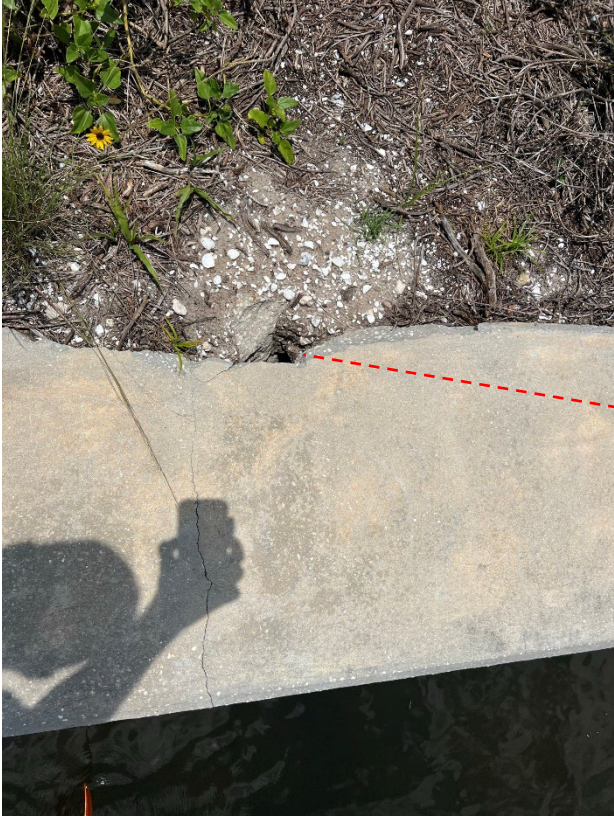
Photo #2 – Spalling in the Cap and Sediment Loss

Spalling/
Chipping

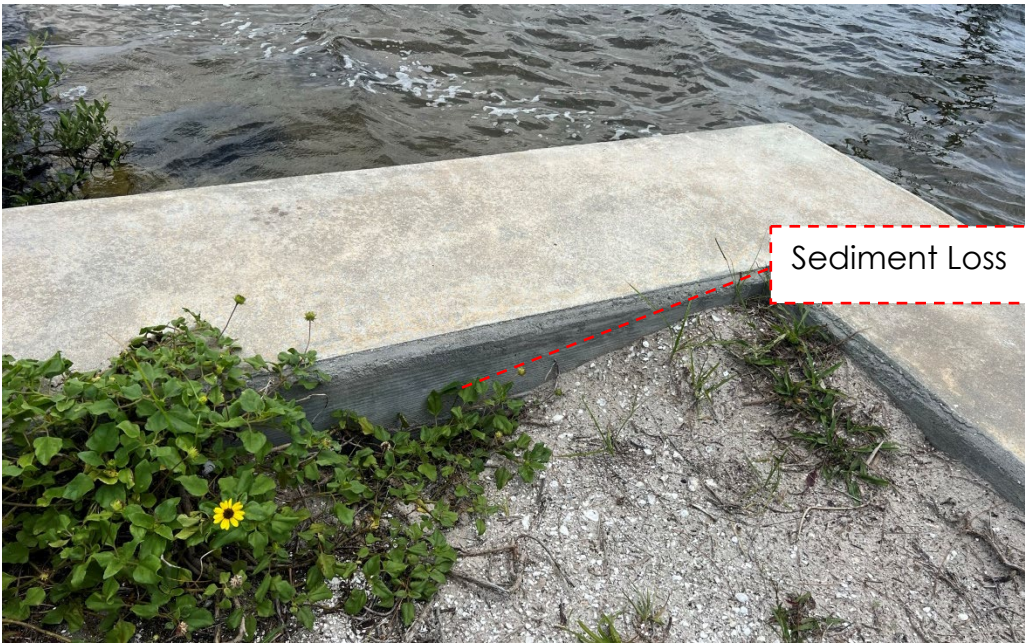
Photo #3 – Sediment Loss.

Sediment Loss

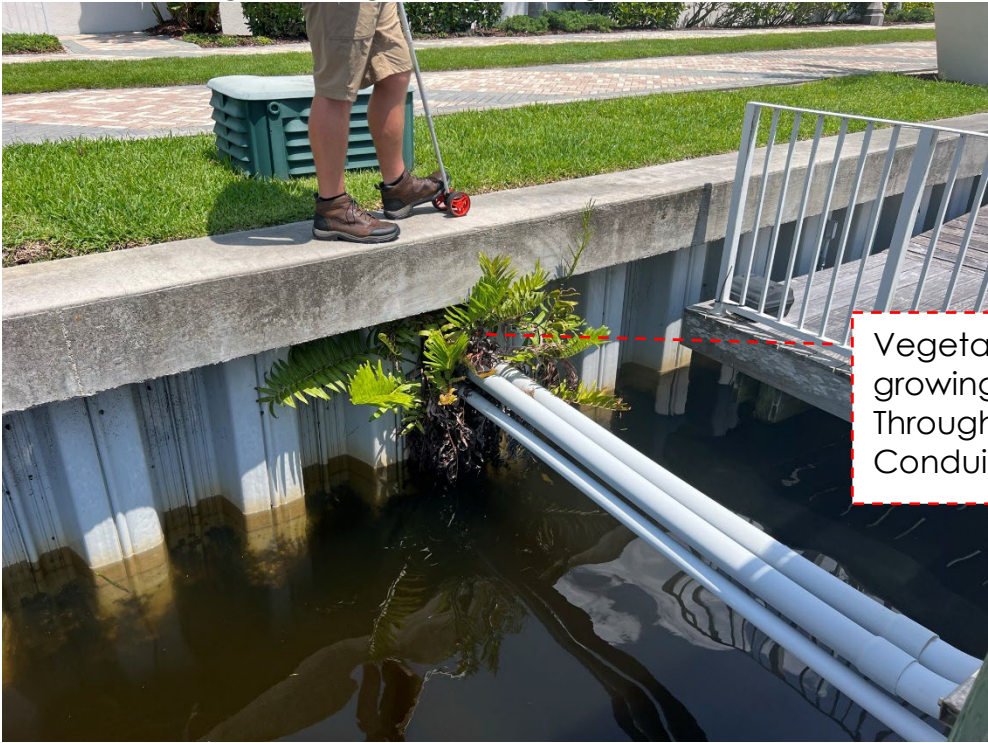
Photo #5 – Vegetation growing Through Conduit.

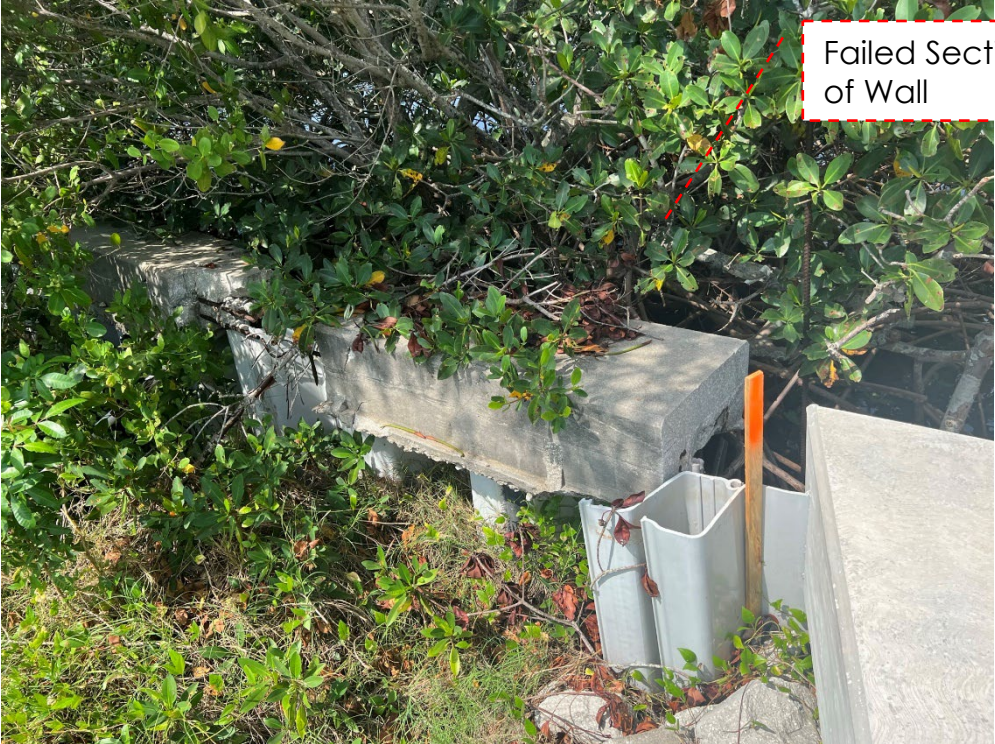
Failed Area in Section 1 (Station 3,878 – 3,986 ft)

Photo #6 – Failed Section of Wall.

Due to the age and condition of the existing seawall system we recommend replacement of the seawall system within 1± years. Recommended specifications for a new seawall would include construction of a new vinyl corrugated seawall system with a new concrete cap and 1" diameter HDG PVC encased tieback rods to Manta Ray anchors or deadmen. Well point drains should be installed through both walls at 6' on center and 5" above the barnacle line to relieve the hydrostatic pressure or aid in removing water from behind the wall. The existing wall may need to be removed. The ballpark cost for this portion of wall in today's prices is approximately \$65,500± with a useful life expectancy of 50 ± years.

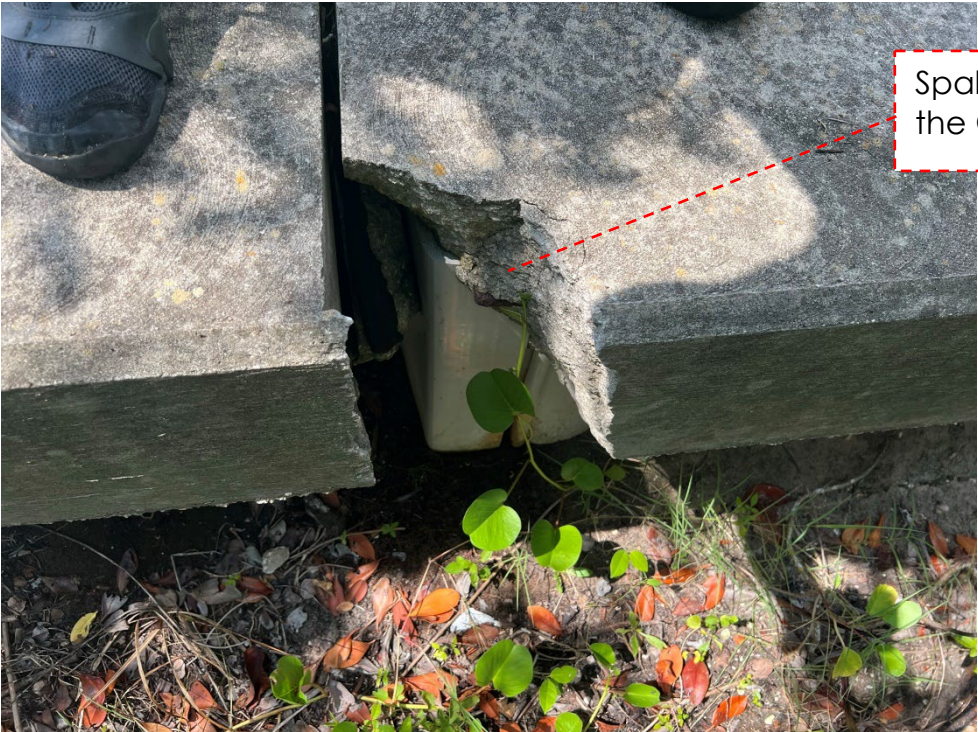
Photo #7 – Typical Spalling of Concrete Cap.

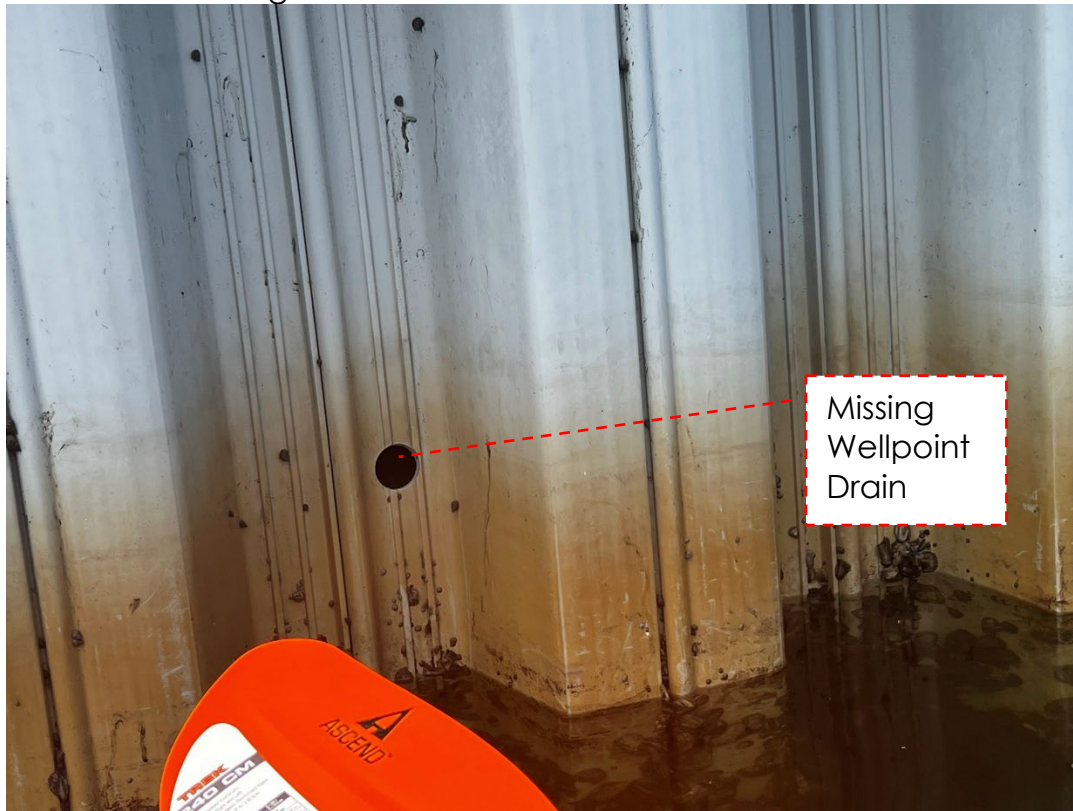
Photo #2 – Missing Drain

Missing
Wellpoint
Drain

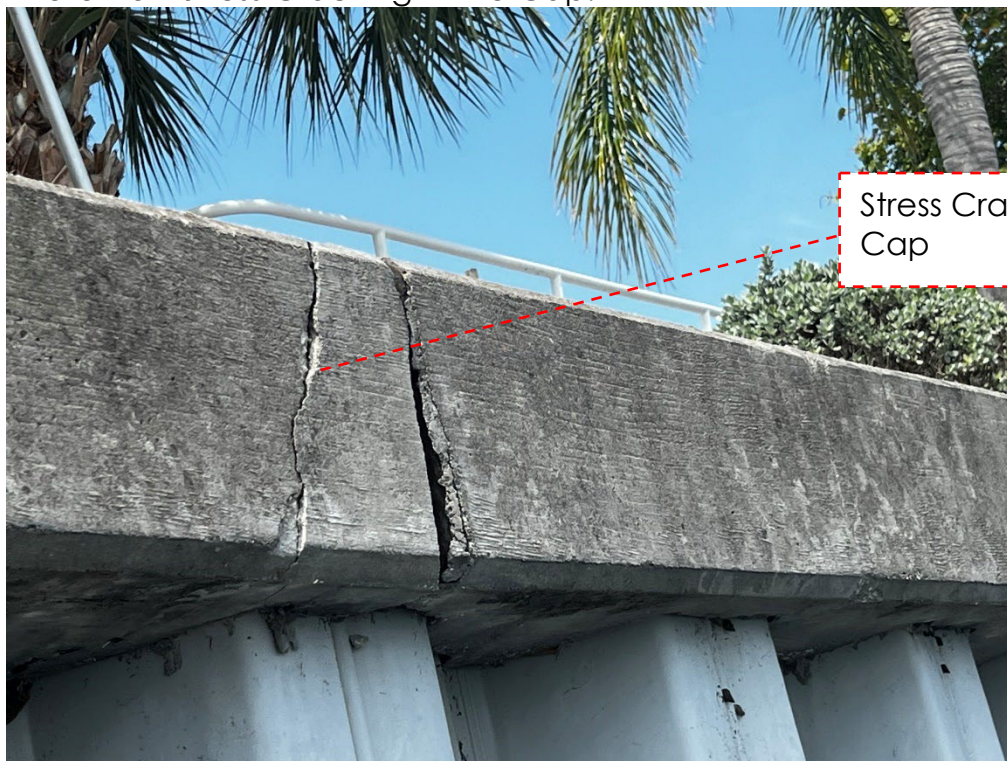
Photo #3 – Stress Cracking in the Cap.

Stress Cracking in the
Cap

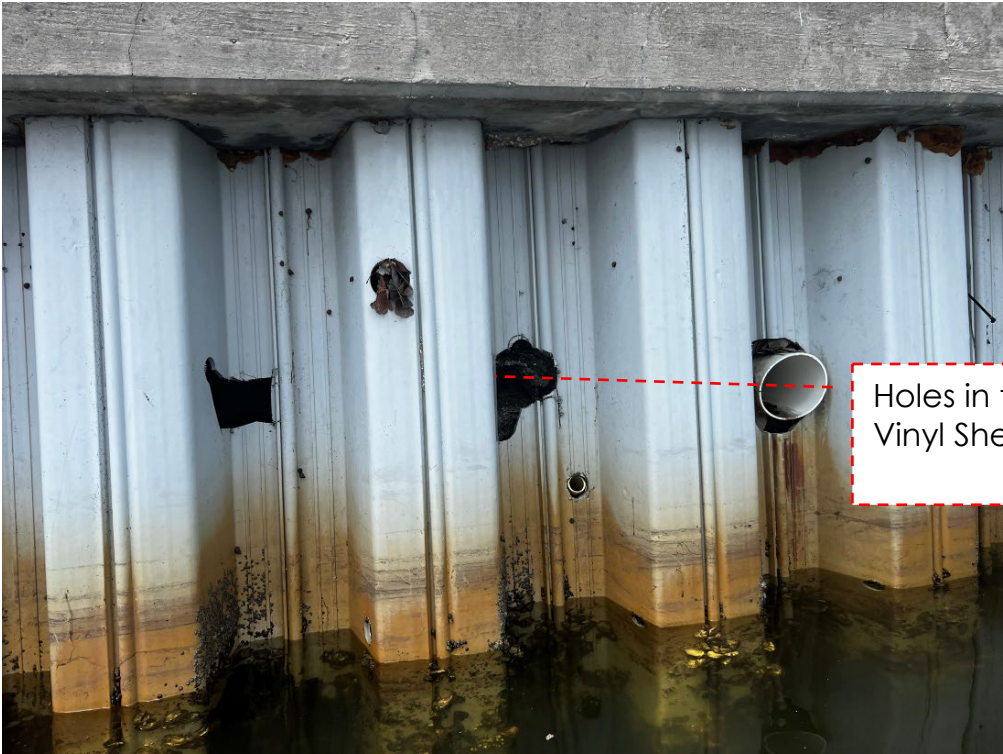
Photo #4 – Holes in the Vinyl Sheet.

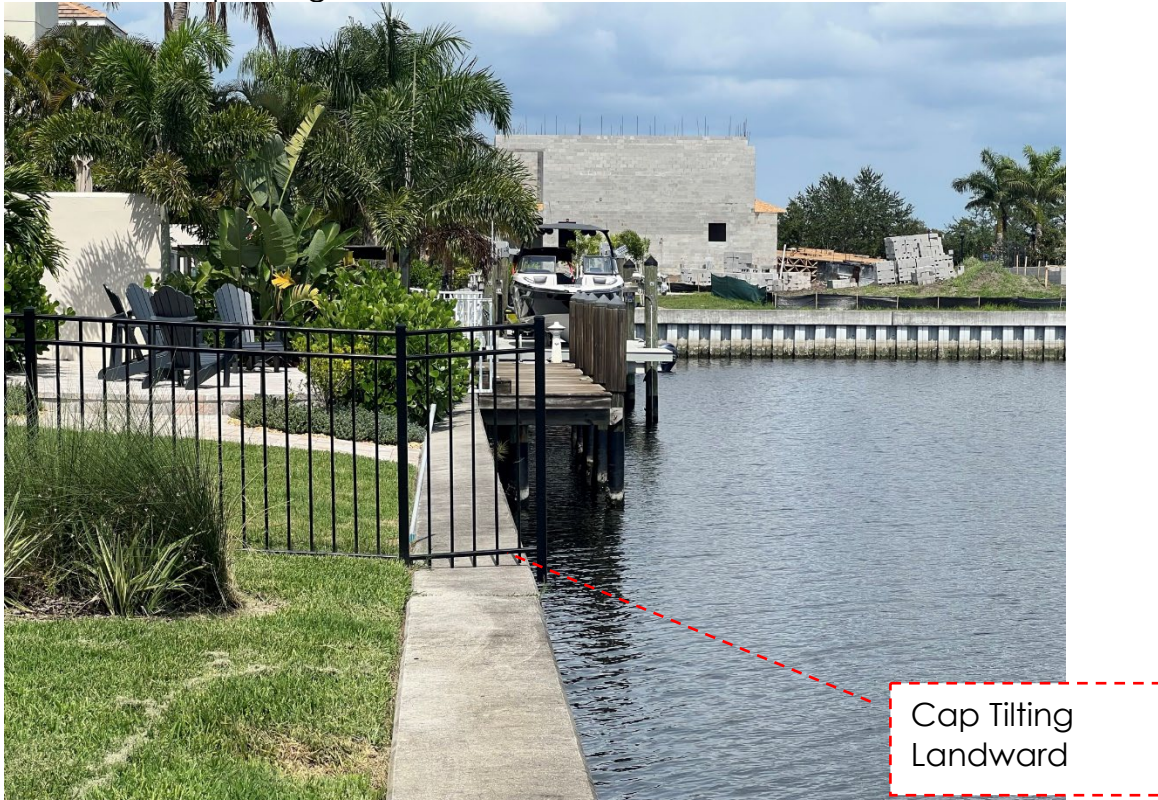
Photo #2- Cap Tilting Landward.

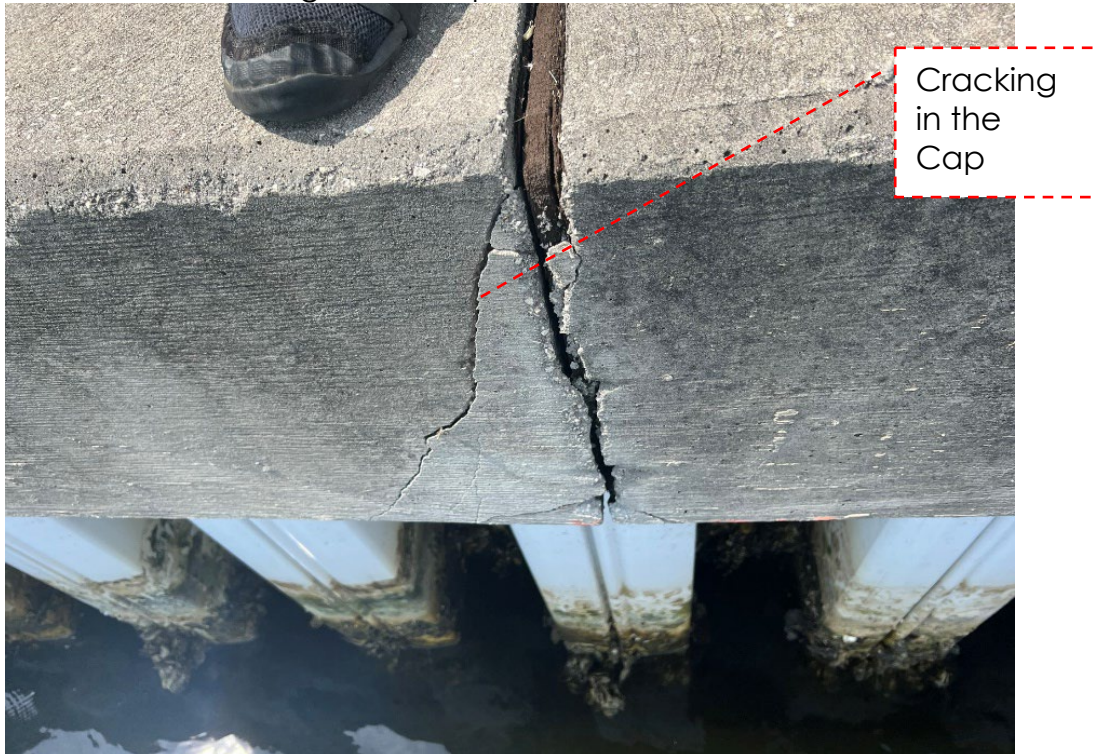
Photo #3 – Cracking in the Cap.

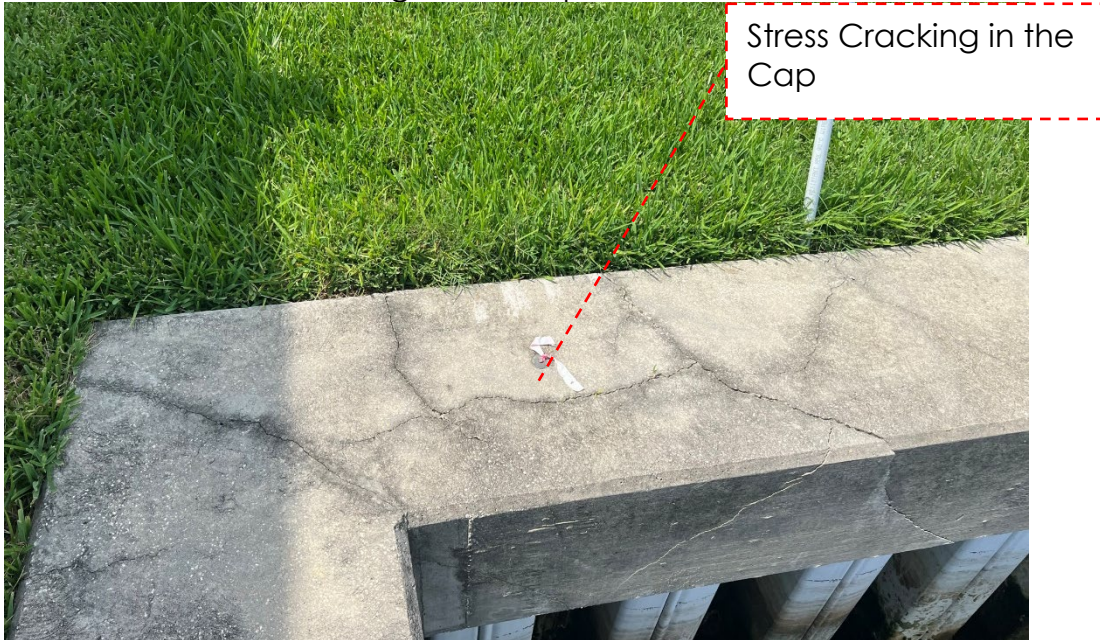
Photo #4 – Stress Cracking in the Cap.

Stress Cracking in the
Cap

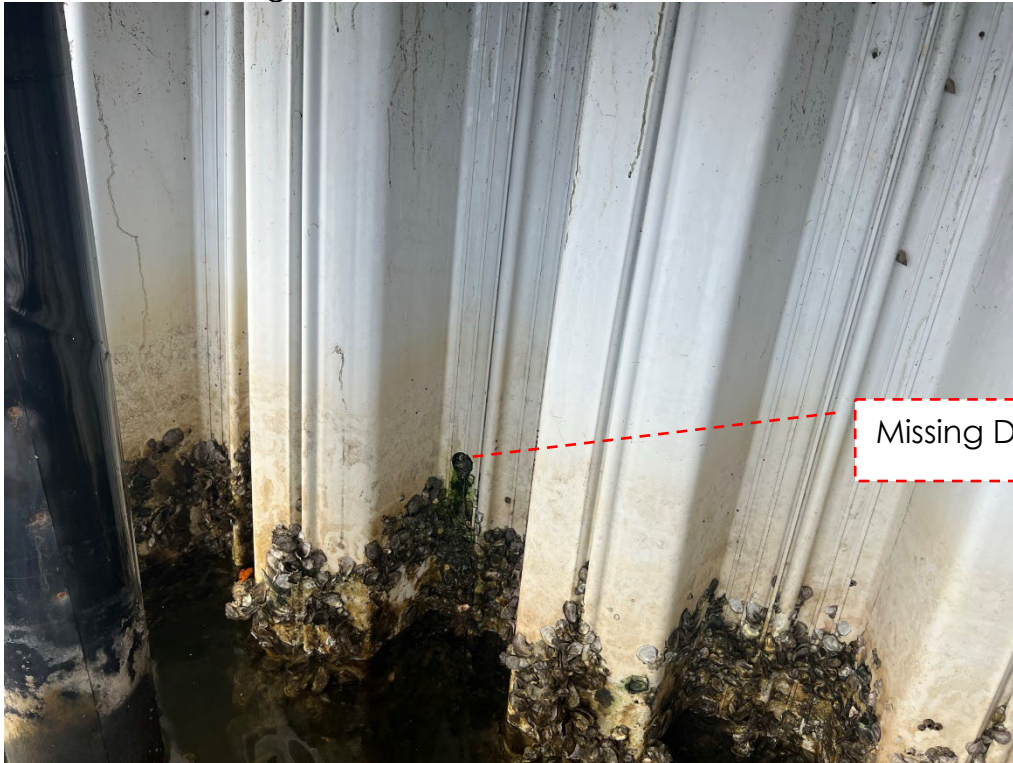
Photo #5 – Missing Drain.

Missing Drain

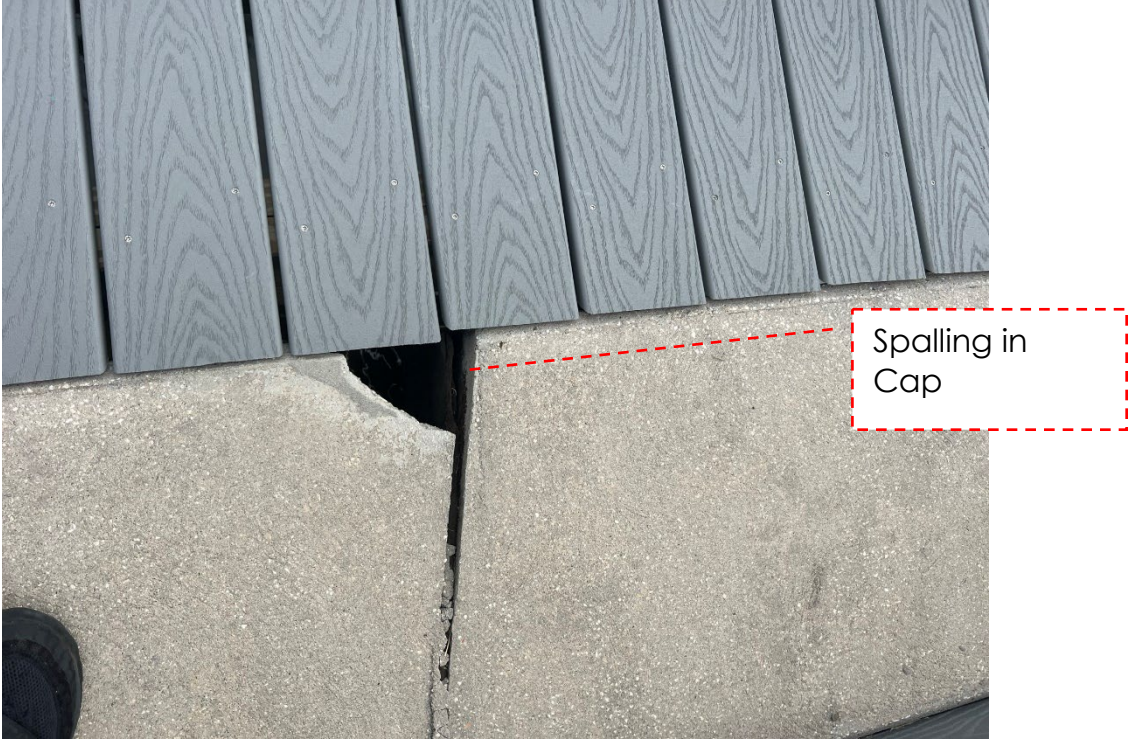
Photo #6 – Spalling.
