South Bay Community Development District

TO: South Bay CDD Board
FROM: Richard Brylanski, PE
DATE: August 2, 2023
SUBJECT: Clarson Seawall Inspection Report Executive Summary

Mr. Richard E. Brylanski, PE, Little Harbor Marina/South Bay CDD
RE: Seawall Inspection Report – 606 Seagrape Dr, Ruskin, FL 33570
July 12, 2023
Page 23

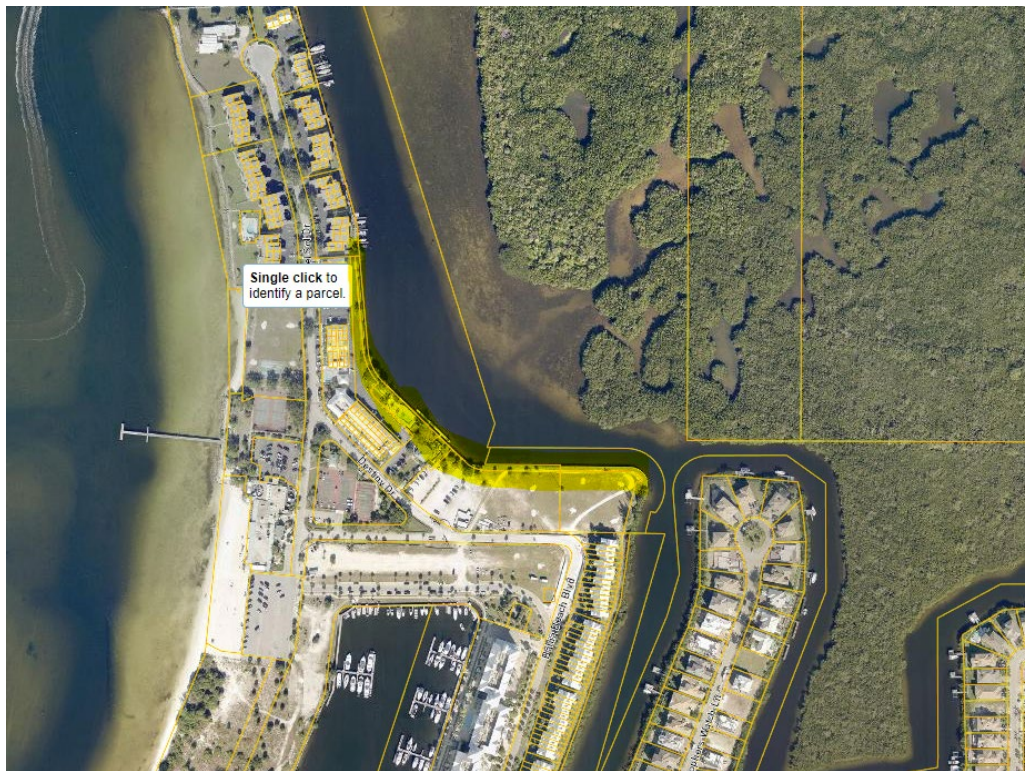
Figure 2: Seawall Section 2 Inspection Area

Section 2 includes approximately 1,400 linear ft of seawall on the south side of Cabbage Creek. The following is a summary of observations at measured stations starting at Station 0 ft which is the east side of the seawall of Section 2. Recommendations have been provided in red text where applicable. Please find below a highlighted aerial of Section 2.

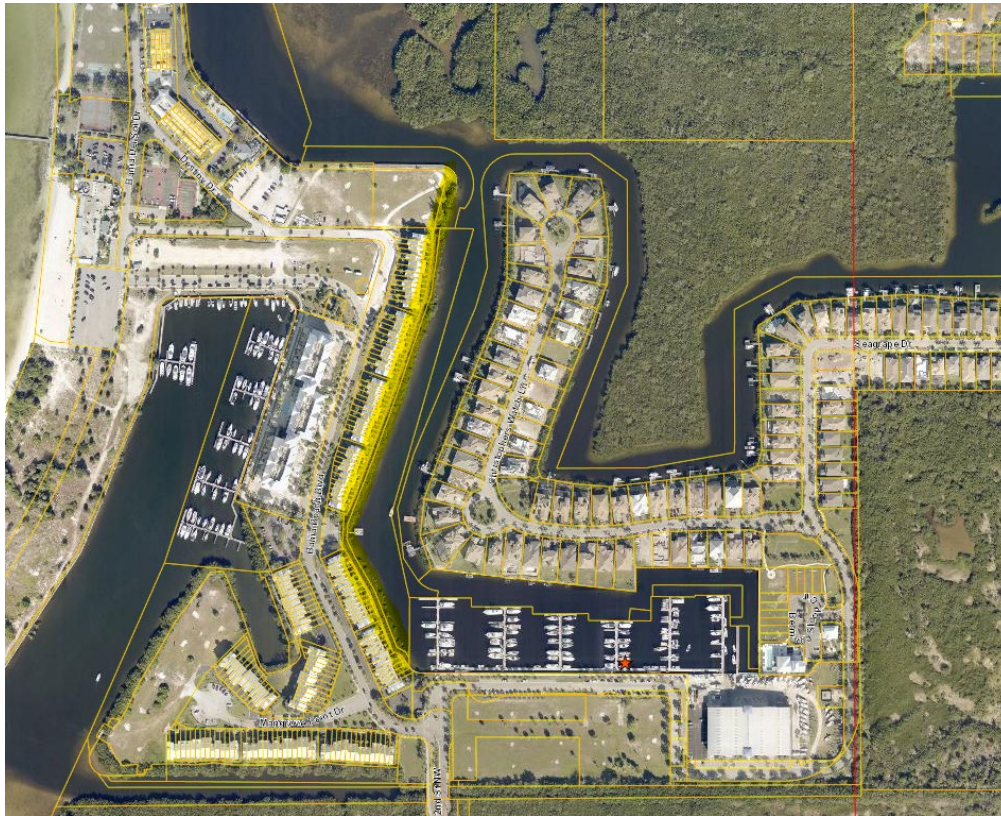
Figure 3: Seawall Section 3 Inspection Area

Section 3 incorporates approximately 1,672 linear ft of seawall along the west side of the entrance/exit channel to the Little Harbor Marina (eastern marina basin). The following is a summary of observations at measured stations starting at Station 0 ft which is the north side of the seawall of Section 3 moving southward. Recommendations have been provided in red text where applicable. Please find below a highlighted aerial of Section 3.

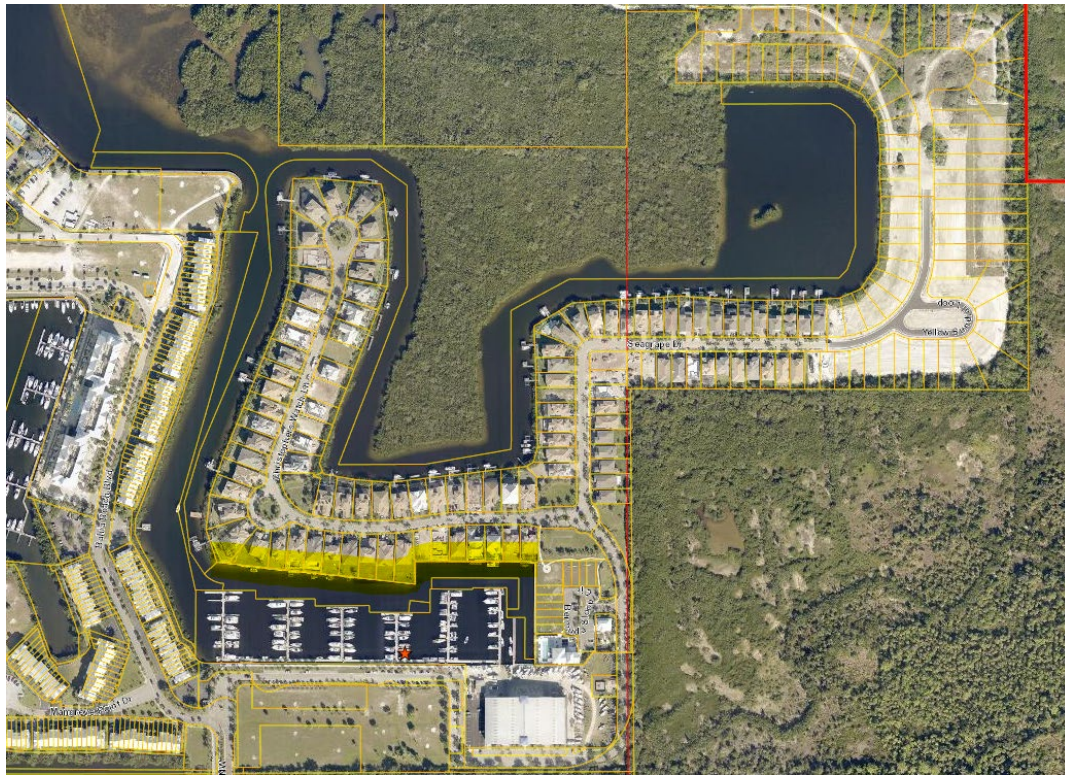
Figure 4: Seawall Section 4 Inspection Area

Section 4 includes 1,139 linear ft of seawall on the north side of the Little Harbor Marina Basin. The following is a summary of observations at measured stations starting at Station 0 ft which is the east side of the seawall of Section 4 moving westward. Recommendations have been provided in red text where applicable. Please find below a highlighted aerial of Section 4.

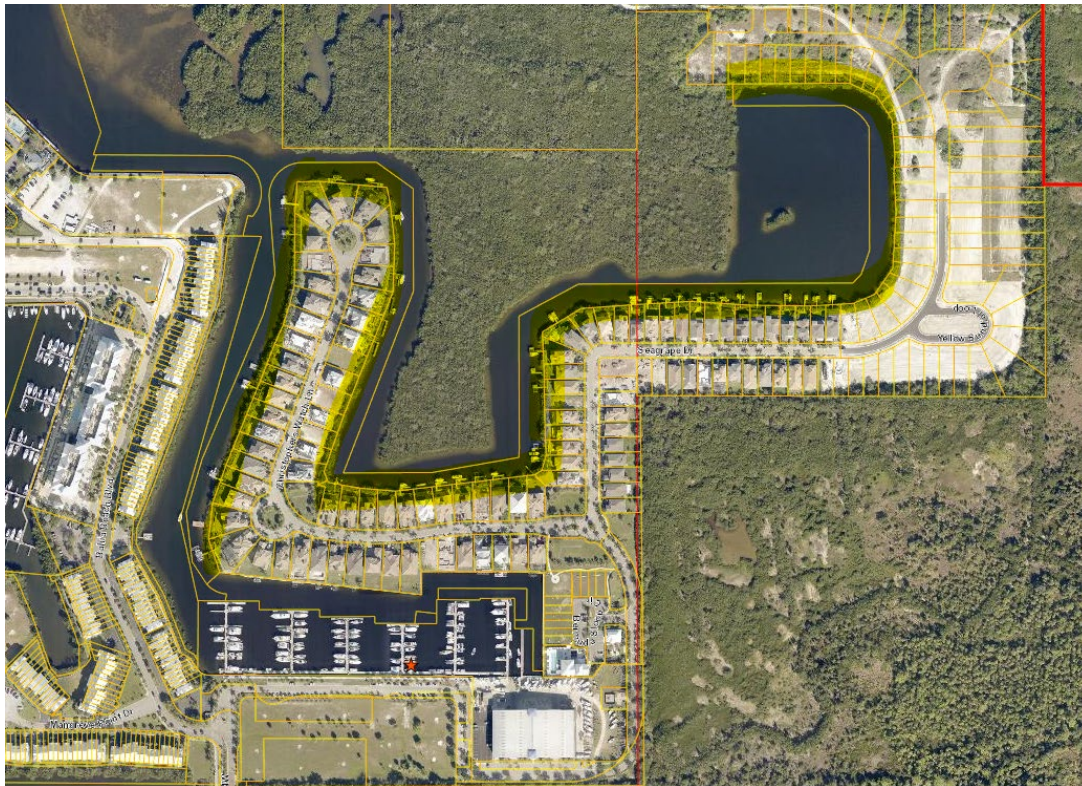
Figure 5: Seawall Section 5 Inspection Area

Section 5 comprises 5,304 linear ft the shorelines along the east, west and north shorelines along Christopher Water Lane; and the west and north shorelines along Seagrape Drive. The following is a summary of observations at measured stations starting at Station 0 ft which is the south end of the seawall of Section 5 heading northeasterly. Recommendations have been provided in red text where applicable. Please find below a highlighted aerial of Section 5.
